# Wind River Habitat Restoration Strategy

SUBMITTED TO  
Lower Columbia Fish Recovery Board

FEBRUARY 27, 2017

PREPARED BY  
Inter-Fluve, Inc., Underwood Conservation District,  
and Lower Columbia Fish Recovery Board in collaboration with the Wind River Work Group.

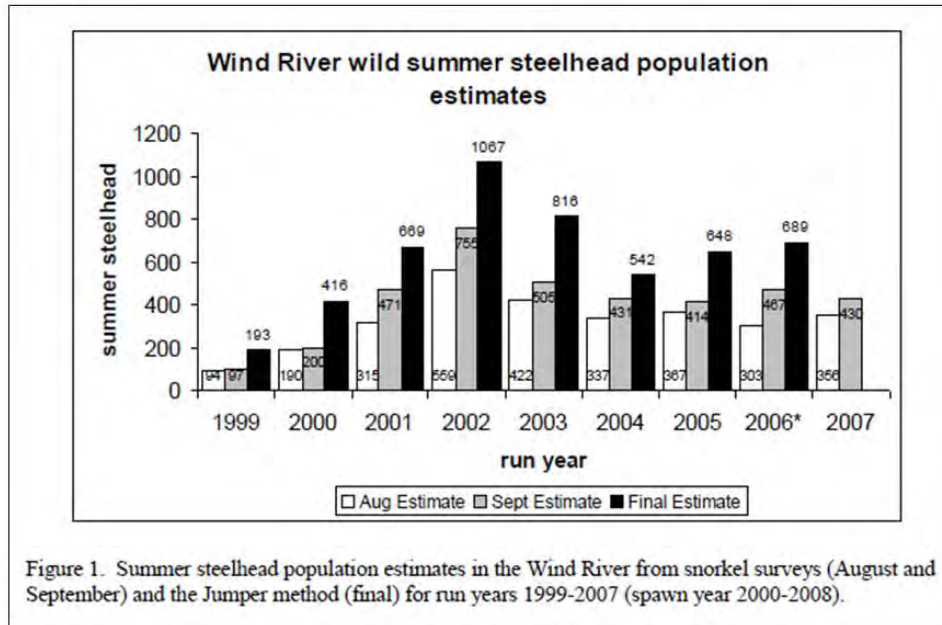
The Wind River was snorkeled from Dry Creek to Shipherd Falls on September 12-13, 2007. Preliminary data analysis from August and September snorkel surveys and from the Trout Creek adult trap is 430 wild, summer steelhead. Additional estimates, 1999-2007, are presented in this graph:

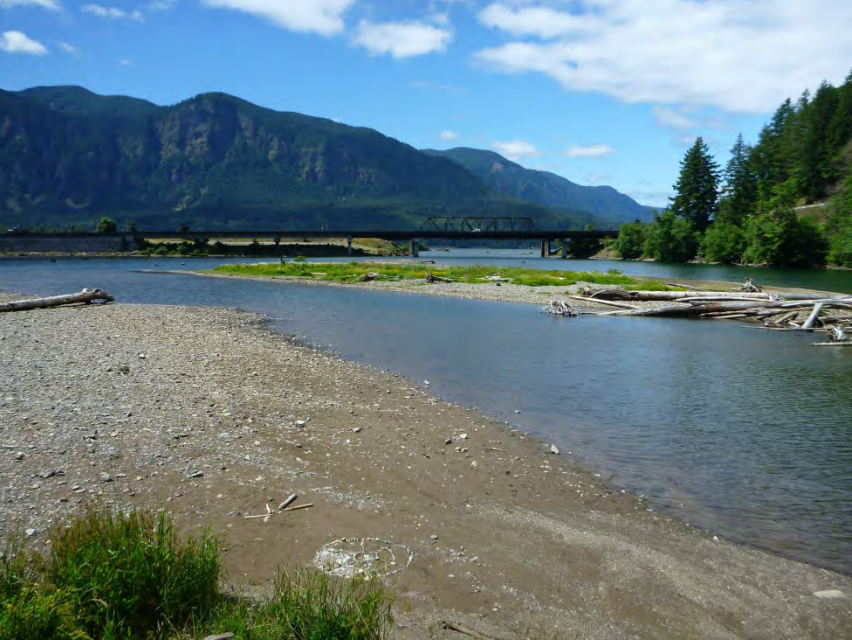
Wind 2	Log Dump Bend	W2	Fill, levees, bank armoring, and docks affect river processes and habitat at the old log dump. At the outside of the bend on river-left, there is erosion of the high bank. Enhance the log dump area to re-create, to the extent possible, river delta dynamics and habitat conditions. This could include removal of the levee at the top end of the log dump, creating a multi-thread side-channel complex through the log dump pond (with vegetated islands), re-grading the right-bank floodplain to increase inundation, and removing or setting back bank armoring, including a section of sheetpile. Actions would also include re-establishment of native riparian and floodplain vegetation. These actions would take pressure off of the eroding left-bank; look for other opportunities to address left-bank erosion, but access is challenging.	Private lands. Work here would likely require land acquisition. Work on the left bank would be challenging given access conditions.

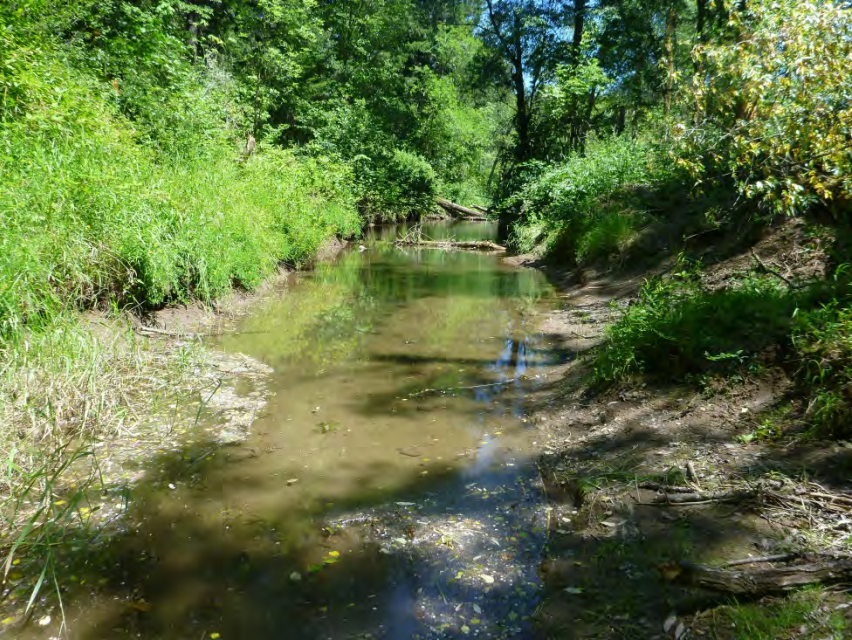
Wind 2	Indian Cabin Road Reach	W4	Uniform reach with riprap along left bank (along access road). Add large jams to right-bank bar to increase planform diversity and multi-thread conditions, and to potentially increase activation of right-bank floodplain/off-channel habitat. Add wood to left-bank riprap to enhance margin habitat. Remove old metal bridge supports.	High energy reach for mainstem jams. Effects on road would need to be assessed. Private Properties.

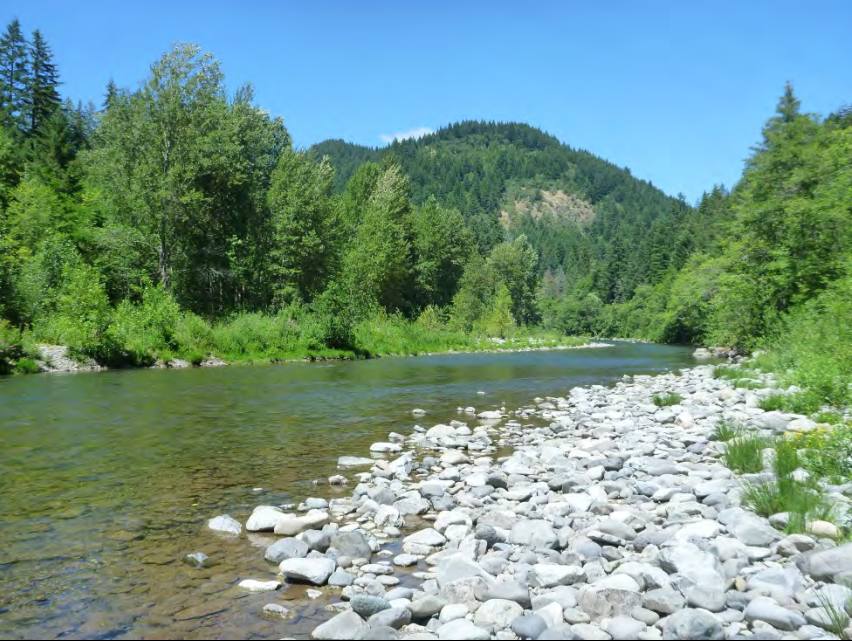
Reach	Project Name	Project Code	Project Description	Considerations	Photo
Wind 5a	Stabler Bend	W5	Activate the complex of channel scars (none are active at low flows). Could put ~20% of flow through here to take pressure off of Stabler Bend. Put in far left bank channel against the hillslope toe. Keep channel against hillslope at downstream end (in the trees). Revegetate open area at downstream end and control for invasives (mainly scotchbroom). Old Stabler log jams at upstream end beginning to deteriorate. At downstream end, some signs of additional erosion and undermining of jams. Possibly place more jams here and/or design a controlled neck cut-off to relieve pressure on this bend.	Depending on gradient and elevation, might be able to activate complex with large wood and select excavation only at the upstream end. Wetlands could be an issue if there is a need for excavation throughout length of side-channel complex. Any work in this area needs to keep in mind imminent avulsion risk across neck at downstream end. Site is private property. There is some interest in controlling Scotch broom but difficult access for owners.

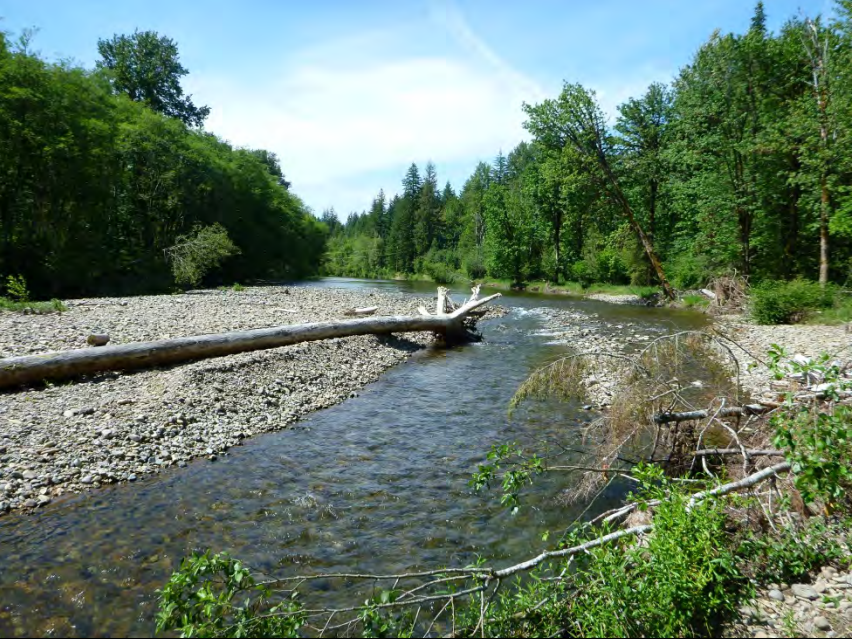
Reach	Project Name	Project Code	Project Description	Considerations	Photo
Wind 5a	Whisky	W7	Uniform reach with Jurzik cut bank at downstream end left-bank and semi-active right bank side-channel. Cut-bank is conglomerate plus mudstone with boulders on the lower bank and alluvium on the upper bank. There is some large wood at the downstream end already. Could mimic this further upstream along bank. Add large wood for complexity and anchor to boulders. Activate the right bank side channel more (currently not flowing). Add right bank margin jams and apex jams. Investigate activating the far right-bank floodplain/side-channel for possibly improving off-channel habitat and taking pressure off of Jurzik cut bank. Replant cleared riparian area on the left bank upstream of the Jurzik cut bank.	Possibly tough access across private property. Anchoring large wood along the cut-bank may be challenging. Activating far right-bank side-channel may be challenging given landowner permissions.

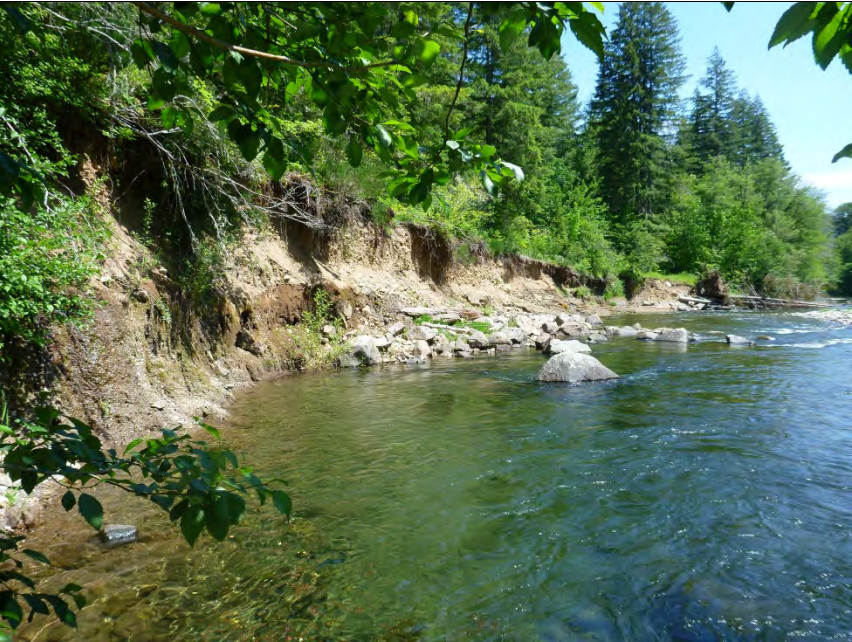
Wind 5a	Cannavina	W8	Multiple private parcels with cleared riparian areas and uniform channel. Look for opportunities to replant riparian zones and add instream complexity using large wood.	Work will take cooperation from landowners.	
Wind 5c	Stump House	W9	This is a newly avulsed section of stream that is currently too dynamic to allow vegetation to establish. Large wood structure using large apex jams would help create and maintain islands and allow vegetation to establish. Could also add large key piece analogs or up-angled rootwads to capture wood. Most of the off-channel areas are fairly well connected but there are some opportunities to enhance connectivity at low flows.	Adjacent landowners that have not given permissions for surveys limits how much of the floodplain was investigated and will likely limit the larger scale opportunities here. UCD has previously placed some wood in a left bank side-channel in this reach.

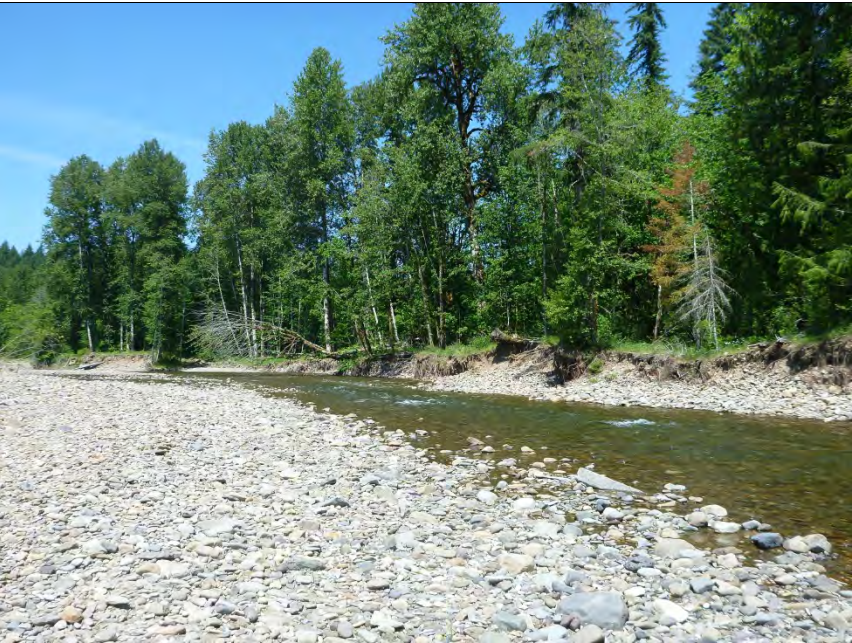
Reach	Project Name	Project Code	Project Description	Considerations	Photo
Wind 5c	Beaver Campground	W10	Levees, fill, and armoring associated with Beaver Campground have significantly impacted floodplain connectivity, off-channel habitat, and instream habitat. There are multiple opportunities for restoration, including: 1) Removal of concrete bulkhead armoring and removal/set-back of associated levee on river-left upstream of CG - creation of low floodplain surface and riparian buffer; 2) Removal/set-back of left bank levee extending downstream along CG, or activation of adjacent side channel; 3) Activate right bank side-channel; 4) Activate left bank floodplain and off-channel complex at downstream end; 5) Add complexity to the main channel throughout, including apex and bank jams,	Campground is the primary constraint. Could it be reconfigured to allow for levee set-back? Past UCD work is located on left bank at lower end, including buried jams, near and at inlet to left bank side channel complex. Goal was to keep the main channel from occupying the side channel but to keep the side channel active. Would be good to increase the level of activation of this left bank side channel complex. There is groundwater flow at lower end of right bank side-channel scar. Could be good to preserve or enhance GW conditions rather than fully activate side channel.

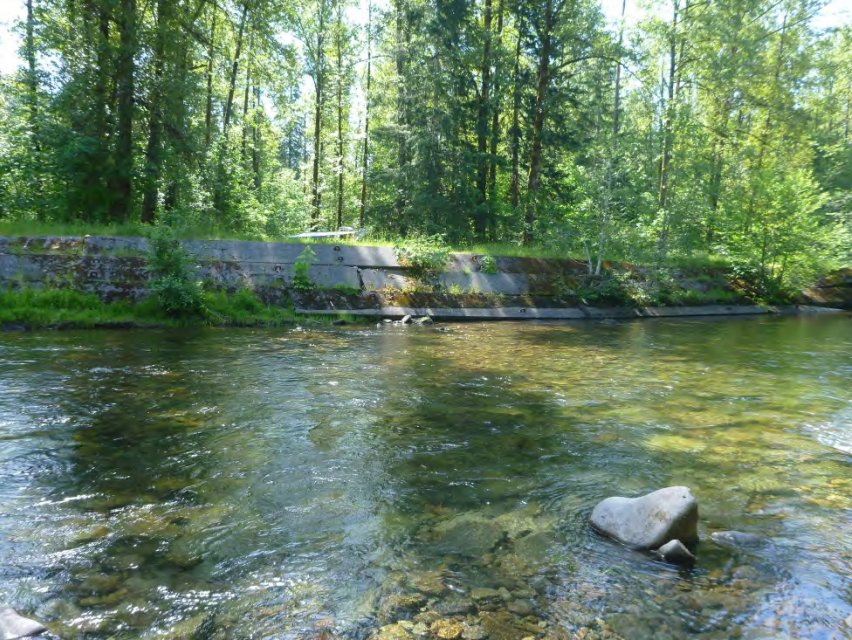
<p>Concrete bulkhead at upstream end of Beaver CG, river-left.</p>

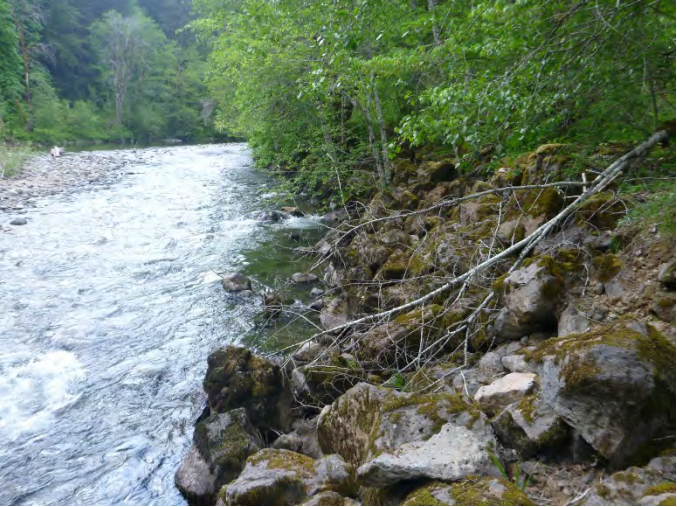
Reach	Project Name	Project Code	Project Description	Considerations	Photo
Wind 5c	Beaver North	W11	Uniform reach with disconnected side channel and riprap bank armoring. Opportunities include: 1) Construct alcove at existing left-bank side-channel outlet at upstream end (groundwater inputs); 2) remove riprap on river left (from Wind River Road) at upstream end of armoring and set back, closer to the road. Create a lower floodplain and revegetate; 3) Activate large side channel scar on the right bank using a large apex jam on bar near the inlet and a left bank margin jam. Load the side channel with large wood. There is a good bar apex/riffle crest from which side channel can be activated. Currently there are large old-growth pieces at jam at head of side channel which can be repositioned and used. Consider shifting main channel into this alignment to remove channel from riprap and bulkhead at Campground. Another option is to enhance the lower end as a groundwater channel; 4) Add wood/complexity in the form of bank and bar apex jams throughout.	Modifying road riprap where road is close would be challenging. May have to enhance in place. There is bedrock located in this reach and needs to be considered when planning earthwork.	<div>

<p>Left-bank riprap</p></div> <div>

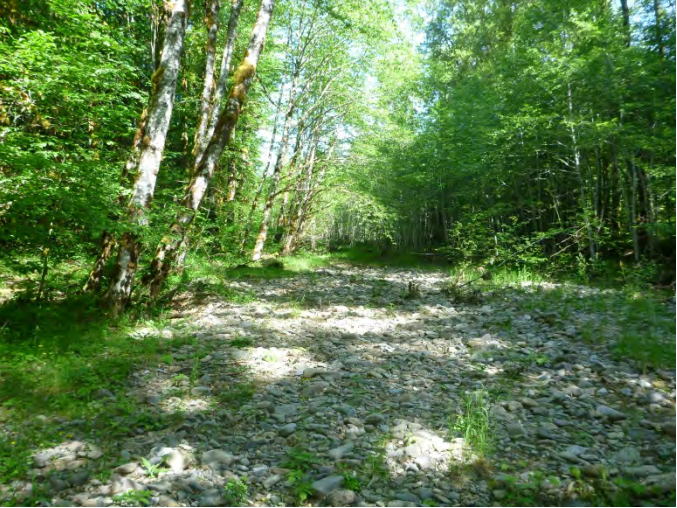
<p>Side-channel scar right-bank</p></div>

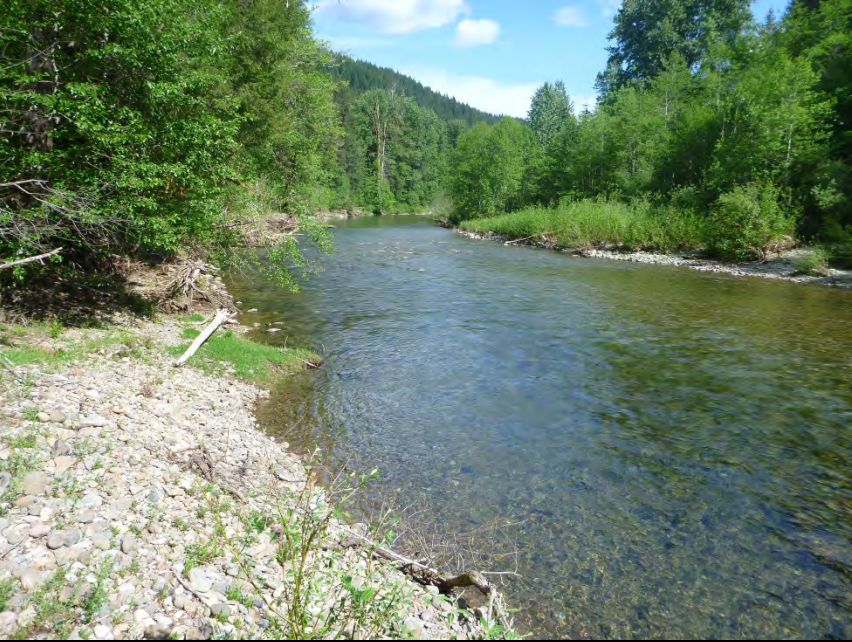
Reach	Project Name	Project Code	Project Description	Considerations	Photo
Wind 5d and 5c	Hatchery Reach	W13	There is abundant potential for restoration of channel and floodplain processes here. Several sub-projects are possible: 1) Remove or set back the levee on left bank near the hatchery to reconnect the left-bank floodplain; 2) Add large wood (apex and big bank jams ) to main channel and active side-channels throughout; 3) Remove fill at head of disconnected right-bank side-channel at upstream end of project reach; 4) Reconnect off-channels, side channels, and floodplain wetlands in the right-bank floodplain across from hatchery (possibly connecting up with side-channel described in #3) where large wood appears to have been placed to prevent channel movement to the west and away from the hatchery entrance; 5) Remove, modify, or enhance left-bank riprap downstream from hatchery entrance; 6) Enhance connectivity of right-bank side-channel complex across from hatchery entrance (re-enters downstream at project terminus) using select excavation and a bar apex jam at inlet; 7) Add complexity (apex and bank jams) at pool downstream of riprap; 8) Create cold water alcove on left bank where Tyee Springs reenters channel.	The hatchery and associated infrastructure presents significant constraints. The contemporary need and function of levees, riprap, and other hydromods needs evaluation to understand realistic opportunities. Past work appears to have been conducted to maintain the main channel in its current alignment, presumably to maintain fish access into hatchery entrance channel. Investigate options for restoring floodplain and channel migration zone processes while maintaining fish access.

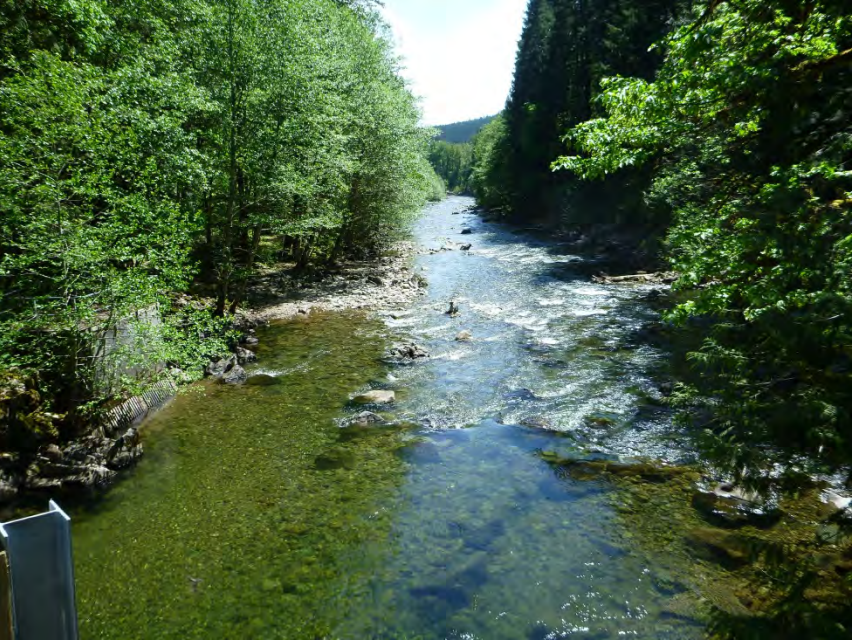
Wind 5d	Mineral Springs Road Bridge	W15	The bridge and associated approach fill on the west side severely disconnected the floodplain and has locked the channel into its current alignment, causing incision, simplification, and lack of off-channel habitat here and downstream. Look for opportunities to increase connectivity through modifying the road fill/crossing or mitigating for these impacts by creating new off-channel habitat features.	Modifications to road fill or bridge would be expensive.

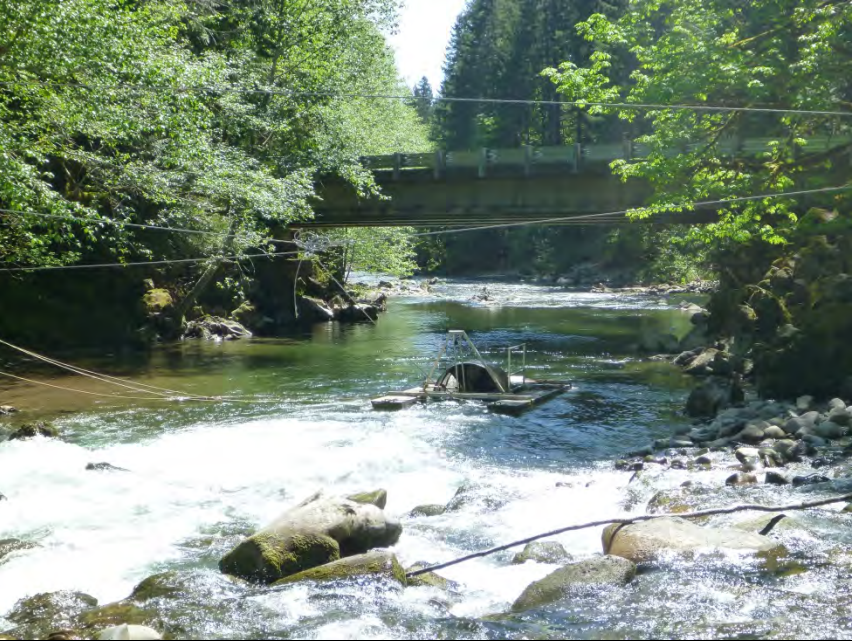
Reach	Project Name	Project Code	Project Description	Considerations	Photo
Wind 5d	Wind River below Trapper Creek Confluence	W16	There is past log jam work through here but more could be completed. Add large apex jams - piling or backfill burial ballasted. Add jams to left bank (be strategic and leave gaps where good recruitment would still occur). Place apex jam on bar towards downstream end.	There are cabled logs just downstream of Trapper Creek on the right bank and an existing apex log jam. There is a newly activated side channel on right bank, with some old restoration logs washed down near here. There is other evidence of placed logs moving - the ones in place are cabled or well-buried. There is a dispersed recreation area on the left-bank throughout.

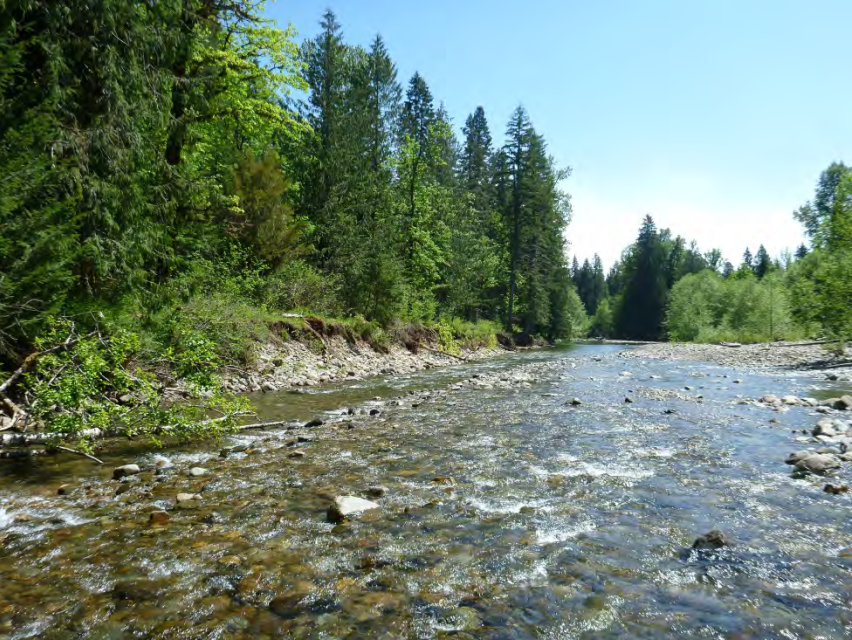
Wind 6a	Wind River below Dry Creek Confluence	W17	This is a very uniform glide with very little in-channel or margin habitat complexity. Add large wood to right bank to create pool scour and cover. Add apex jam just above Trapper Creek confluence.	There is an existing dirt access road along the river-left bank.

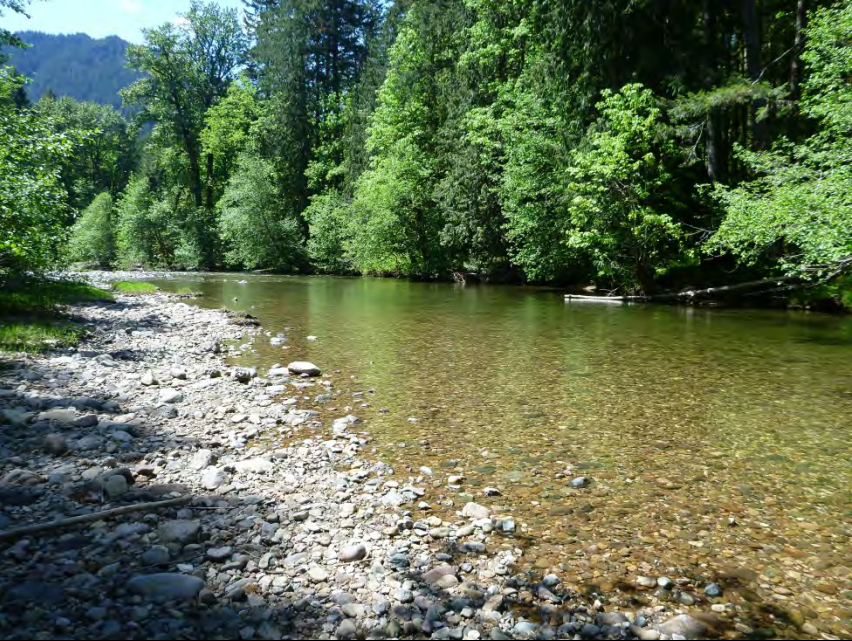
Reach	Project Name	Project Code	Project Description	Considerations	Photo
Wind 6c	Falls Confluence Highway Slope	W18	Over approximately a half-mile, the high road prism abuts the channel, with intermittent (sometimes heavy) riprap and impacted riparian vegetation. Look for opportunities to establish woody vegetation on the highway slope and to increase margin complexity in the channel using large wood. There are a few pieces of placed large wood at the base of the riprap from old projects.	Riparian work on highway slope could be challenging and large wood margin complexity along the riprap may not be worth it.

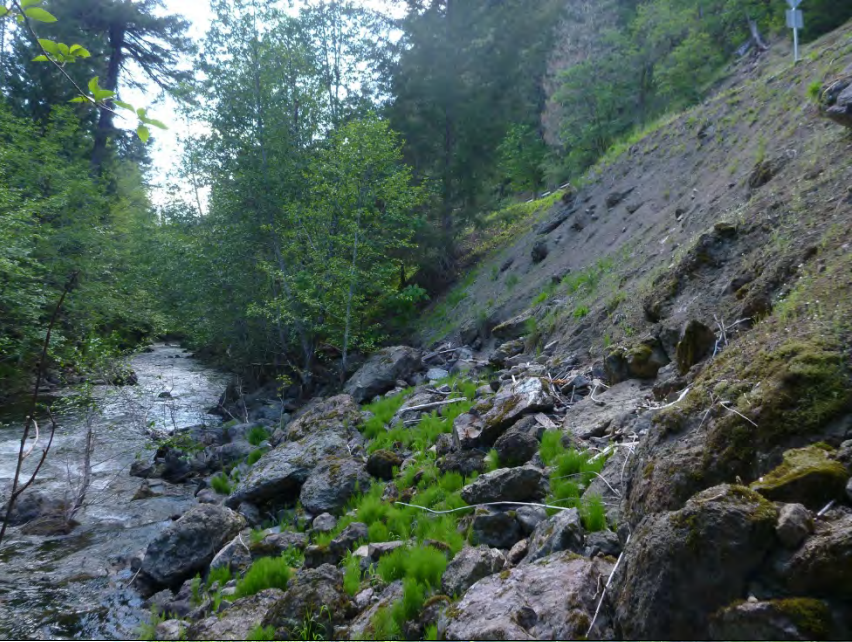
Wind 6d	Mining Downstream Road Contact	W19	A 50' riprap section appears to have been an emergency placement after big firs were recruited. Riprap is intermittent, with areas of failure. This is a multi-thread channel with some flow farther east - very complex. Shift the channel away from highway toward valley-left using log jams. Use jams along highway to prevent re-occupation of channel adjacent to highway. Establish a riparian buffer between river and road. Add large wood key pieces throughout the channel to capture numerous smaller deciduous large wood in the channel. There is a second riprap section along road at downstream end where margin complexity could be increased, but road bank is high and canyon is starting here so there is less impact or opportunity for improvement.	There are road integrity and safety issues at these sites, which could boost importance and help with funding.

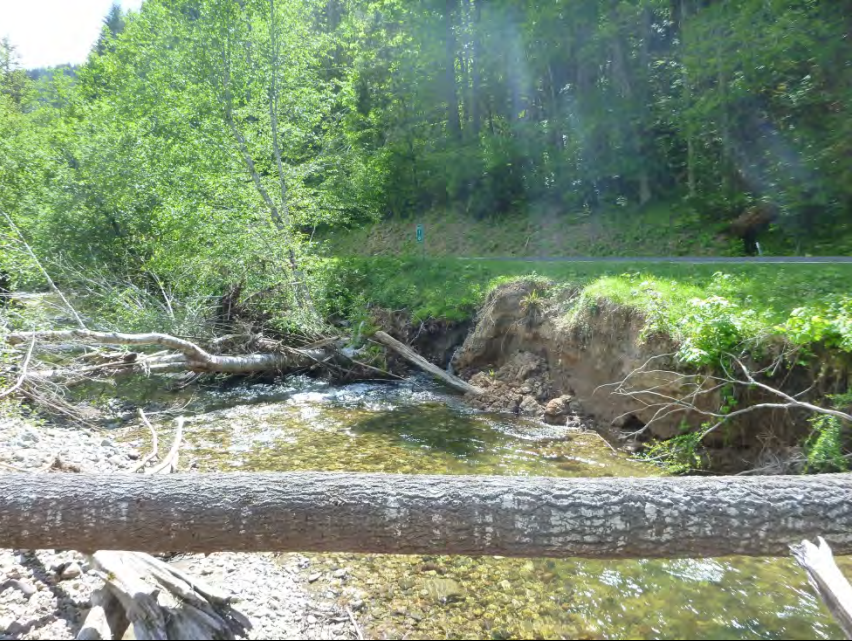
Reach	Project Name	Project Code	Project Description	Considerations	Photo
Wind 6d	Mining Middle Road Contact	W20	Two locations of highway riprap along right bank. At the downstream location, the riprap has failed or might soon fail. Near RM 22.9 the riprap is failing and a jam is putting the highway at risk. There is an old dry channel in the left bank floodplain that would be an easy place to shift the channel. Shift the channel away from highway toward valley-left using log jams. Use jams along highway to prevent re-occupation of channel adjacent to highway. Add large wood key pieces throughout the channel to capture numerous smaller deciduous large wood in the channel.	There are road integrity and safety issues at these sites, which could boost importance and help with funding.

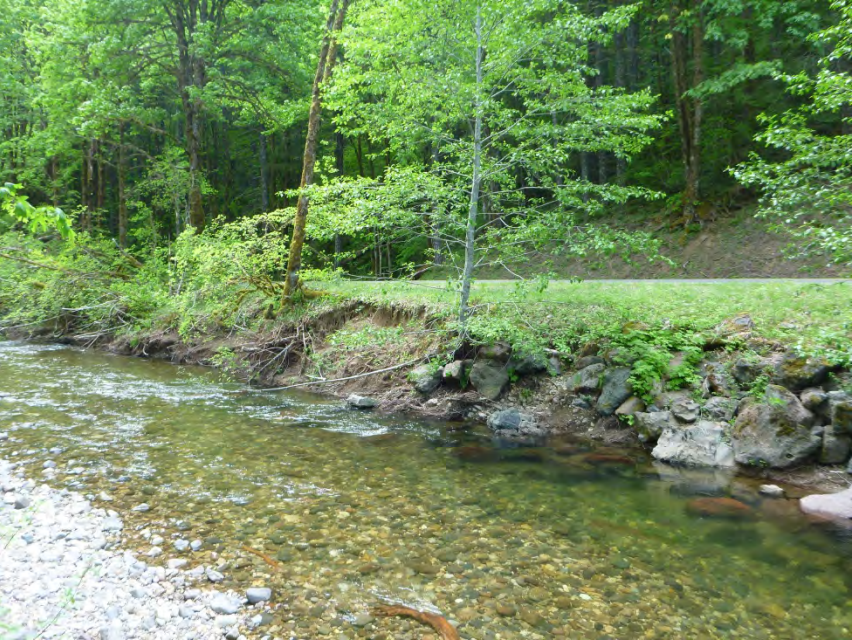
Wind 6d	Middle Butte Fan Large Wood	W21	Channel is currently very uniform and single thread. It has a higher gradient and is more confined from left bank fan. It's likely a constriction/valley grade control for depositional reach upstream. Young alder and maple are present on the right bank floodplain (less than 10" diameter). The left bank is a higher disconnected surface (fan). Add large wood "key" pieces (~0.2 miles) for complexity and to create pocket pools and to retain gravels. Large wood placements would recruit small/young large wood.	Access from Wind River Highway or helicopter drop key pieces.

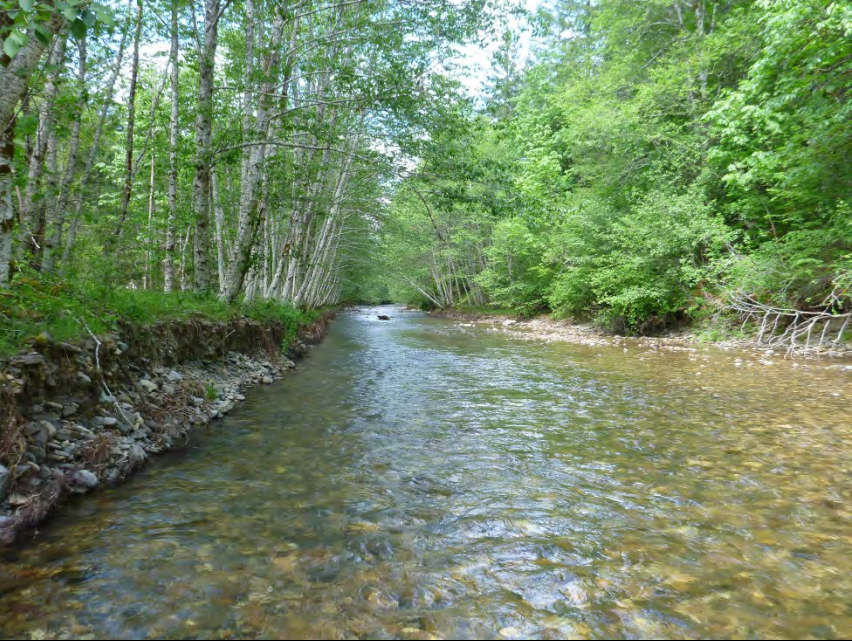
Reach	Project Name	Project Code	Project Description	Considerations	Photo
Wind 6d	Mining Upstream Road Contact	W22	Add large wood jam to right bank at the upstream end of the riprap. Possibly force river channel to shift into left bank floodplain (depending on elevation).	Potential to shift channel into left bank at the upstream end might be more feasible than at other locations.

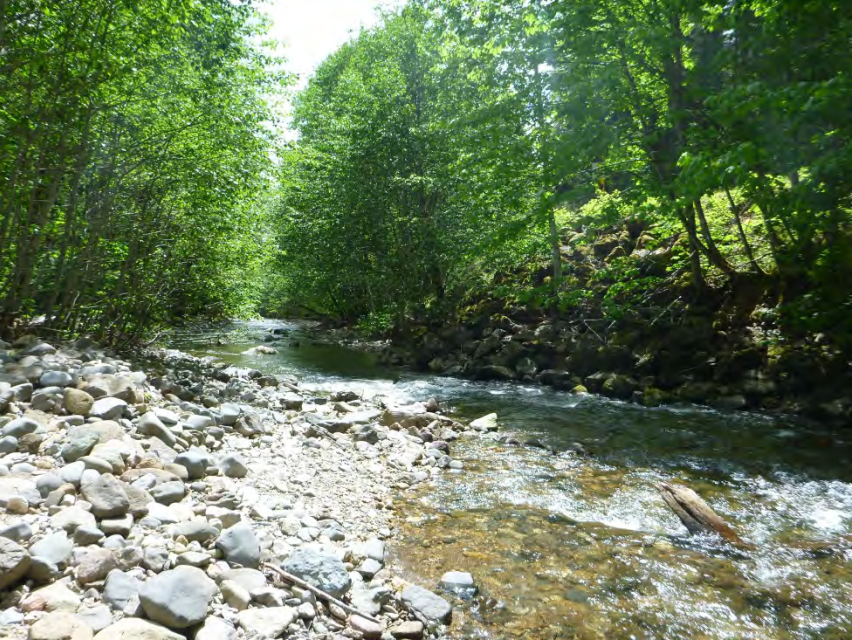
Wind 6d	650 Road Fill	W23	There is an old bridge approach fill/levee causing severe floodplain disconnection on right bank. A concrete abutment is located at the end of the fill approximately 10' from the active channel. Riprap is also located along the edge and at the end. A concrete abutment and road fill is also located on the left bank, with a couple of pilings still present. The left bank has a higher surface (above the floodplain elevation) so the encroachment on the floodplain is not as severe. Also present nearby at the end of the 650 spur road is a dispersed camp site with a 40' long berm and riprap. Remove right bank bridge approach fill/levee. Also remove left bank approach (at least the fill closest to river). Add instream habitat complexity - key pieces to capture alders and maples that have been recruited and will be coming down.	This is the old highway alignment. There is good access from spur road off of Wind River Highway.

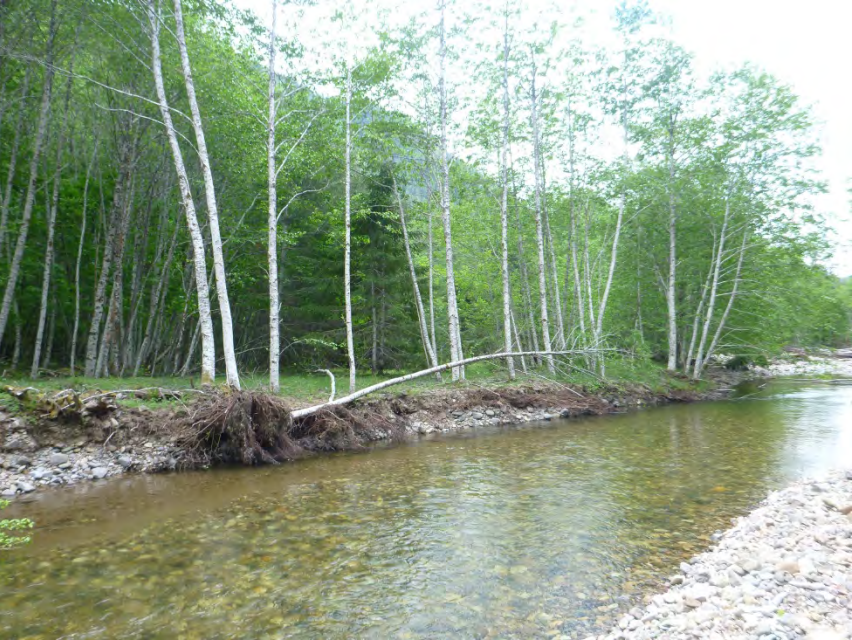
Paradise Creek	Paradise Campground Off-Channel Enhancement	P1	Right bank off-channel habitat potential. Excavate a low-flow side channel. Remove old push-up levee extending approximately 200 feet along right bank. Add apex jam (use existing LW) to encourage erosion on the left bank and recruitment of large trees and floodplain activation upstream at the top of the existing right bank bar.	Potential effects to eroding left bank along campground will need to be evaluated.

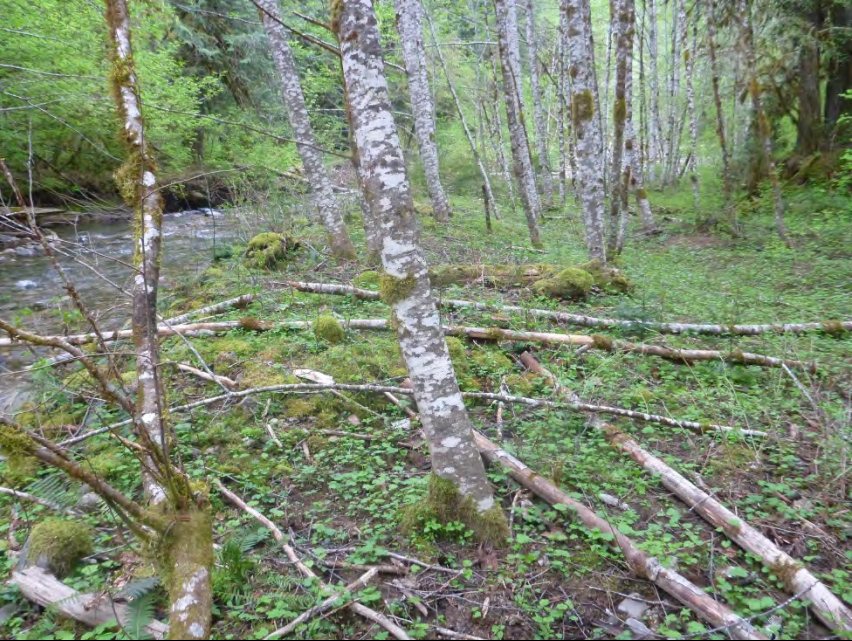
Reach	Project Name	Project Code	Project Description	Considerations	Photo
Paradise Creek	Paradise Bridge	P2	Increase the bridge span length to reduce floodplain constriction and increase the channel migration zone. Removing associated armoring would enhance margin complexity.	Costs may be prohibitive.

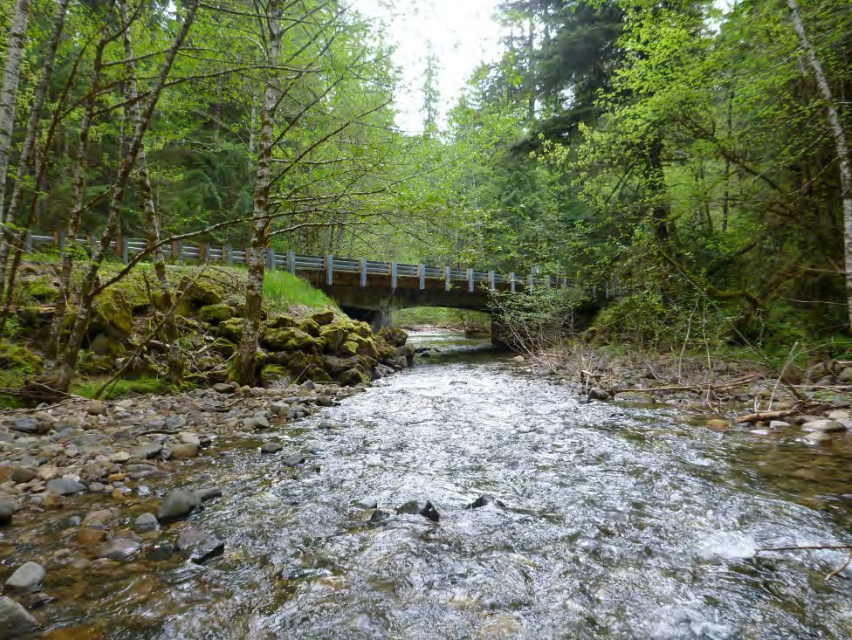
Paradise Creek	Paradise Creek Large Wood	P3	Use LW jam(s) to aggrade channel and activate floodplain. Use existing large key pieces currently spanning the channel (not much wood but a few large (3'-4' diameter) pieces). There is an opportunity to maneuver these logs together, add additional wood (including, potentially, newly dead snag trees on site), to create a log jam behind existing key pieces. The goal would be to aggrade a slightly incised channel and activate the adjacent floodplain.	<p>Relatively large buffer (100'?) between stream and Wind River Highway, but floodplain would need to be evaluated for hazards to infrastructure. There is a bridge downstream.</p> <p>Past incision indicated by inset floodplain with lower current bankfull width. Alders on lower surfaces potentially from 1996 flood. New signs of aggradation on lower surface might signify channel is on an aggrading trend.</p>

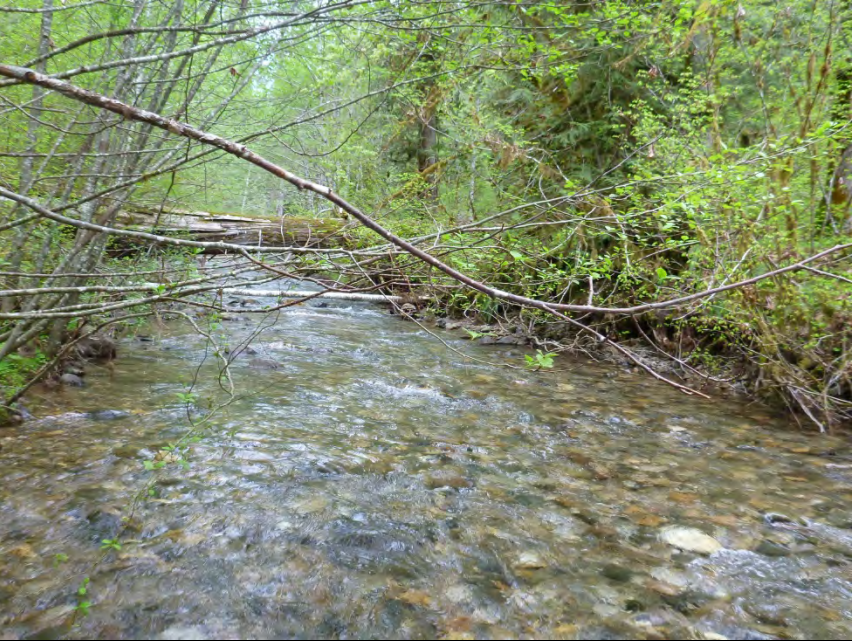
Reach	Project Name	Project Code	Project Description	Considerations	Photo
Dry 1	Lower Dry Creek	D1	This project site is between the mouth and the beginning of the bedrock canyon. It is low gradient and alluvial with large active gravel bars and active scrolling. Needs large wood structure. There has been past work through here, including margin log placements at the upstream end and an engineered jam near the downstream end. Opportunities include: 1) Add wood, either construct margin and apex jams or add large key pieces that can collect smaller wood over time. Place jams to strategically erode banks where good tree recruitment would occur; 2) Use jams and select excavation to activate floodplains, side-channels, and alcove habitat. Lots of opportunity through here.	The effects of seasonal subsurface flow on fish needs to be evaluated before performing work here.

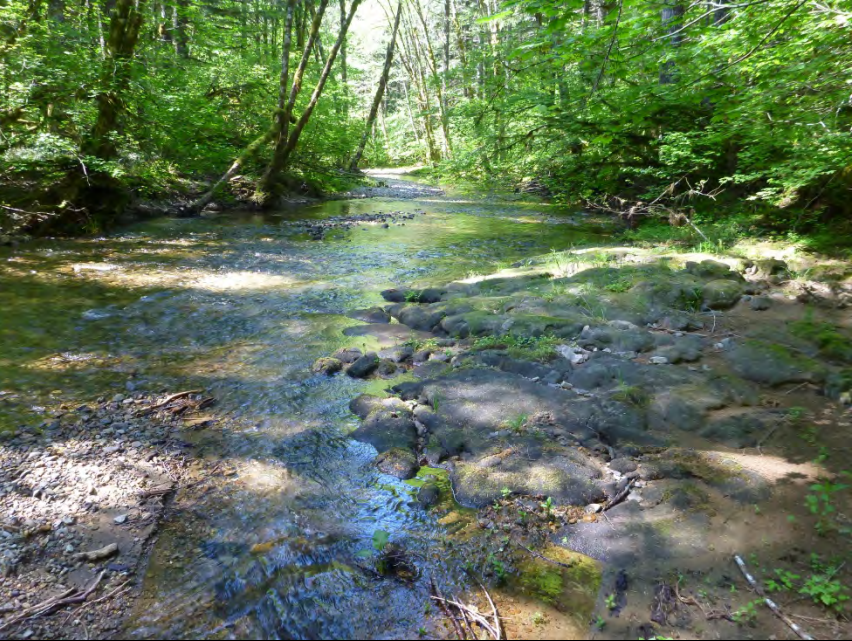
Reach	Project Name	Project Code	Project Description	Considerations	Photo
Dry 1	Spoil Bank	D3	"Spoil Bank" forms cross-floodplain levee on river-left, which disconnects floodplain connectivity and limits off-channel habitat. There is past project work upstream in left-bank floodplain to enhance side-channel habitat. Remove spoil bank to reconnect floodplain. Create new side-channels and enhance connectivity to existing floodplain habitat in both the left- and right-bank floodplains. Enhance mainstem complexity (there is very little large wood throughout here). Plant riparian conifers (cedars) throughout.	Spoil bank material could be moved closer to road to avoid impacts to floodplain connectivity. Past project in left-bank floodplain could be enhanced by increasing level of activation of side-channel.

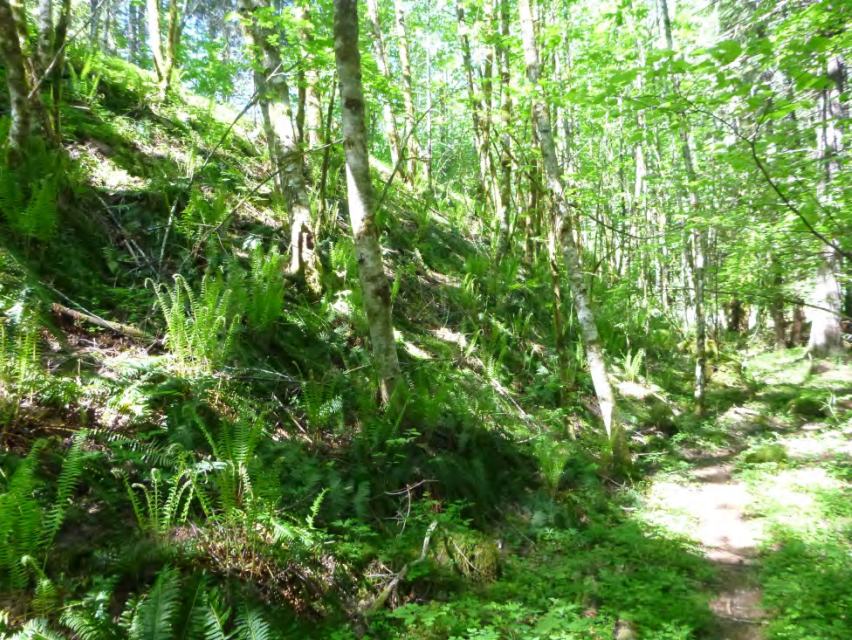
Dry 1	Upper Dry Creek Key Piece Supplementation	D4	Reach has woody debris but most is small and riparian areas have young trees, mostly deciduous. Add large key pieces, possibly by helicopter to limit impacts. This would create stable key pieces to form and maintain jams. Good locations for placements are intermittent and do not encompass the entire project reach. Some areas through here have high complexity, with numerous smaller debris jams. Could also fall select large cottonwoods and maples (there are large ones >2' dbh).	Access from Dry Creek Road, may be challenging in places and will impact riparian zones.

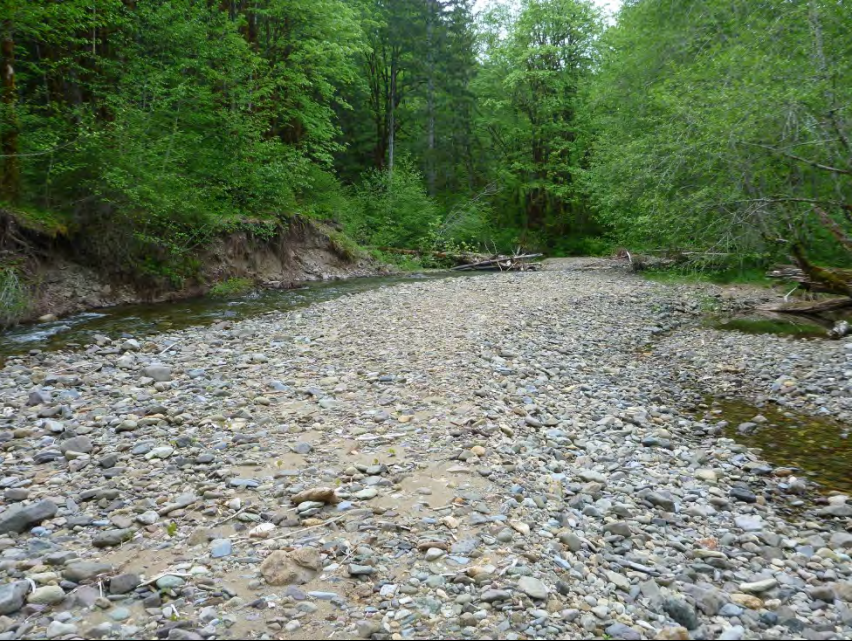
Reach	Project Name	Project Code	Project Description	Considerations	Photo
Dry 2	Forest Road 64 Crossing	D5	The FR64 fill bisects and disconnects the Dry Creek floodplain significantly (original floodplain is wide, ~300 ft here). Culvert at FR64 is an 11' diameter CMP with side baffles but no streambed material. The downstream 15' of culvert is fast shallow flow then 1.5 ft drop to a deep pool, which probably limits passage at some flows (high and low). There are also two log sills downstream of the outlet pool, presumably to address passage issues. Upstream of FR64 crossing there is nothing to do: old growth, well-connected floodplain, good riparian cover and structure, and lots of wood, off-channel habitat, and deep complex pools. Downstream of the 64 road is more downcut and the floodplain is not well connected. There is a more open canopy and less old growth, less off-channel habitat, less active gravel bars, and sediment starved from the road crossing. Replace culvert with long bridge or multiple large culverts to enhance passage and floodplain connectivity. Add channel-spanning jams to downstream channel to aggrade stream, activate floodplain, and provide habitat complexity.	Floodplain and habitat enhancements downstream from the road crossing will have limited value if the road fill remains in place and continues to create a sediment deficit. The effects of seasonal subsurface flow in lower Dry Creek on fish needs to be evaluated before performing work in upper portions of Dry Creek.

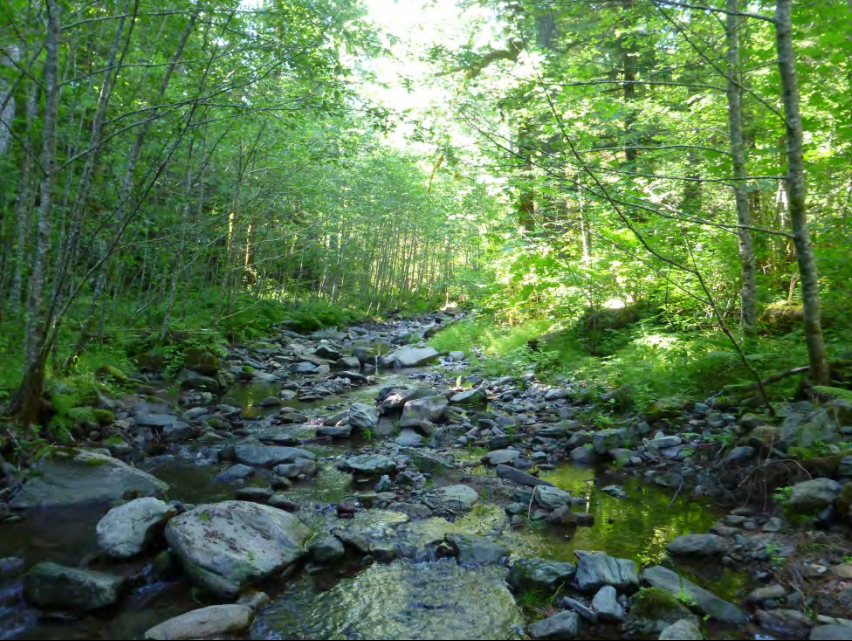
Reach	Project Name	Project Code	Project Description	Considerations	Photo
Trout Creek	Meadow Crest	T1	At top end, both sides of river, especially on the north bank, there is a wide (~100') forested riparian area and stream is continuous riffle. There are no log jams in this reach. Add one or more log jams to capture gravels and provide cover habitat. Existing trees may be able to be used for anchoring. In middle and downstream, also potential sites for log jams, possibly incorporating recent blow down (3-4 logs).	Private lands and potentially challenging access.

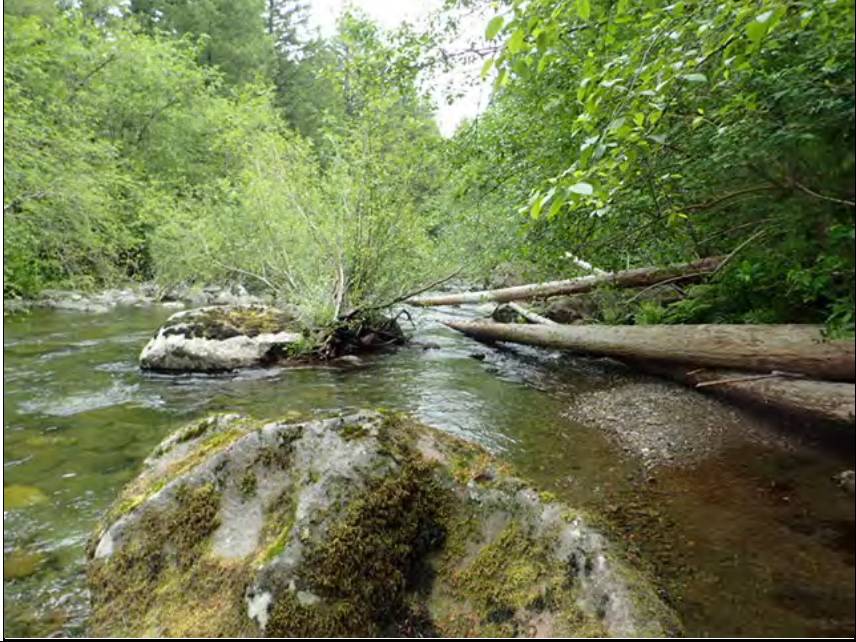
Reach	Project Name	Project Code	Project Description	Considerations	Photo
Trout Creek	Summer's End	T2	This is the most complex area in this reach downstream of Hemlock Bridge. Conditions include a 150ft+ side-channel (left bank), a vegetating cobble bar, a steep south bank with existing mature conifers, and a couple of large logs currently on the south stream bank, plus a small row of alders near these logs. Add one or more engineered log jams in/across the north bank side channel or keyed into the alder screen and existing LWD on south bank. Maybe additional opportunities for log jams downstream.	Private lands and potentially challenging access. Potential access via Summer Road. Top photo shows north bank and existing log and main channel. Bottom photo shows portion of side channel, looking upstream.

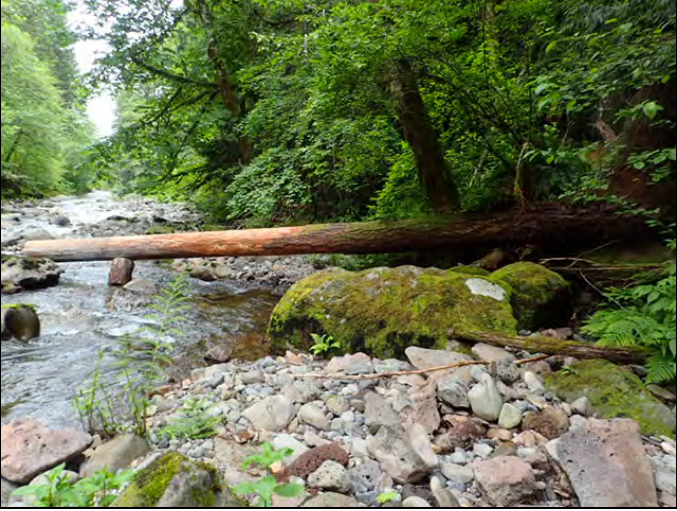
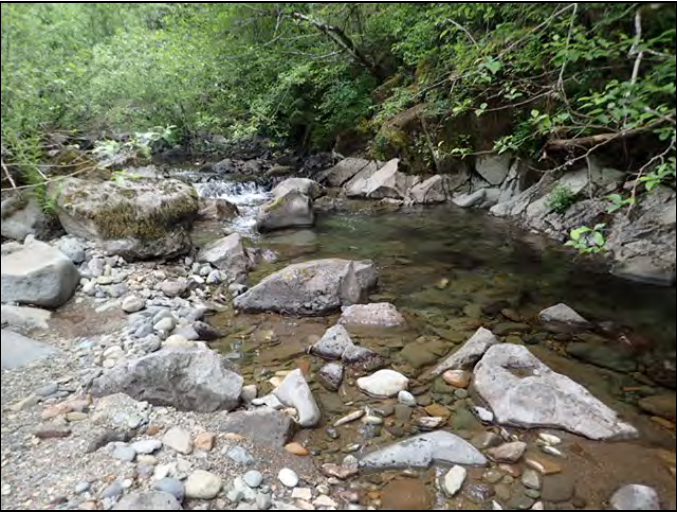
Reach	Project Name	Project Code	Project Description	Considerations	Photo
Martha Creek	Martha	M1	Upstream portion is young riparian forest and downstream portion is older forest. Add wood and jams to scour pools, capture gravels, activate floodplain, and create side-channel habitat. In middle and downstream areas, consider felling trees into channel from the occasional high banks. Place jams strategically to cause erosion to recruit large riparian conifers.	Federal and county property. Good access via nursery property. Seasonal subsurface flow conditions, and impact on fish, should be considered.
