# Wind River Habitat Restoration Strategy

SUBMITTED TO  
Lower Columbia Fish Recovery Board

FEBRUARY 27, 2017

PREPARED BY  
Inter-Fluve, Inc., Underwood Conservation District,  
and Lower Columbia Fish Recovery Board in collaboration with the Wind River Work Group.

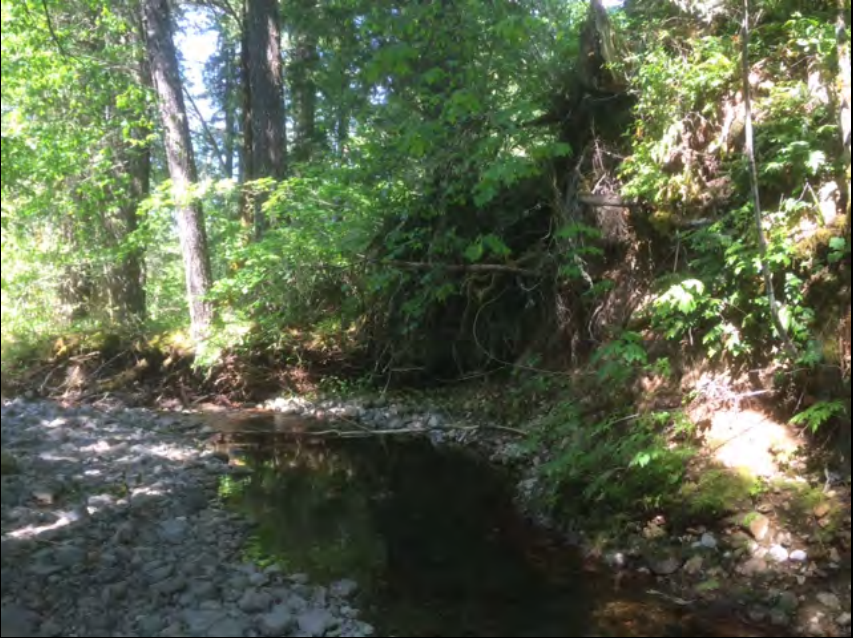
Little Wind 1	Pipeline	L1	Confined valley with narrow alternating floodplain surfaces. Much of it is boulder/cobble plane-bed channel. Low large wood and young alder dominated riparian zone. Add large wood and small log jams, including excavation of scour pools. Similar to past work performed in downstream reach by UCD. This is essentially a continuation of that effort. Wood placements will add direct habitat, maintain scour pools, and help to activate floodplain surfaces and side-channels. Good opportunity for channel spanning jams to activate floodplains and create forced pool-riffle morphology. Could fell fir trees from nearby hillslopes and maneuver into channel.	USFS (Scenic Area) property. The river-right road is too high for access, but can move machinery up-valley by crossing back and forth and tracking up alternating floodplain surfaces. Felling and maneuvering into stream nearby firs using grip hoist may also be an option.

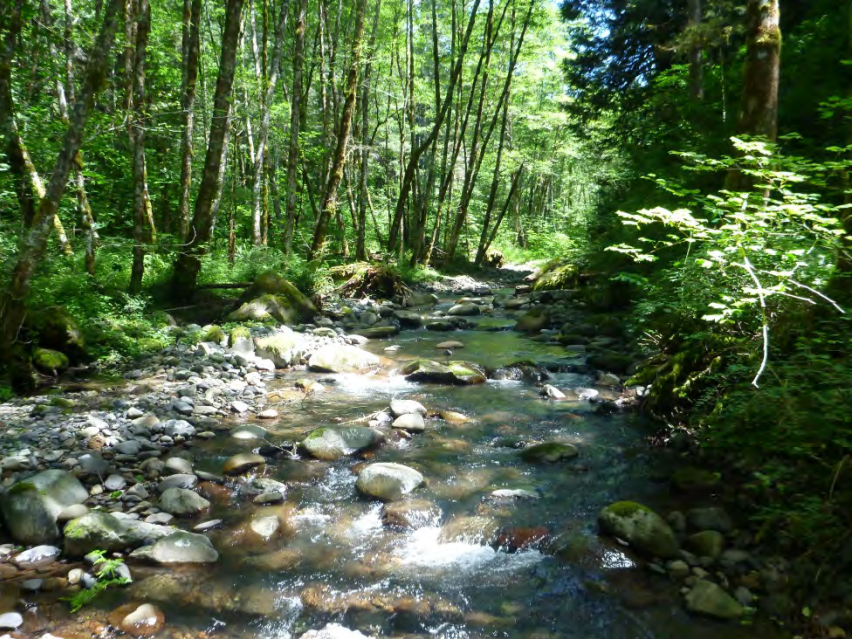
Reach	Project Name	Project Code	Project Description	Considerations	Photo
Little Wind 1	Berge Confluence	L2	Similar conditions as L1. A few long riffles with no habitat complexity. There is more wood through here than in L1, but several stretches are plane-bed with no wood. Selectively fell large firs from nearby hillslopes and maneuver into stream to help build jams to create scour pools, increase complexity, collect gravels, and activate the small floodplain surfaces and short side-channels. There also may be some downed wood (including spanners) that could be maneuvered into the channel.	Machinery access challenging. Likely accomplished using hand crews with grip hoists pulling down firs on hillslopes. Helicopter placement may also be an option.

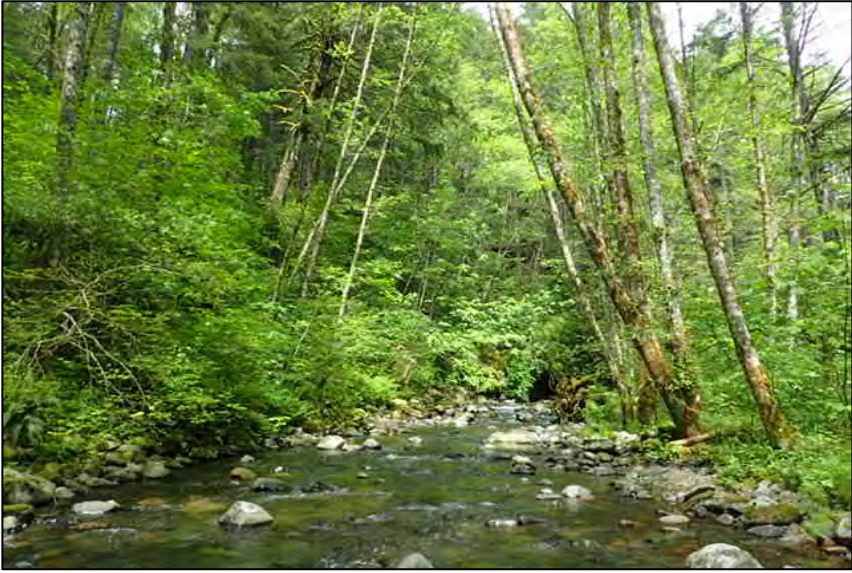
Dillon	L3	Similar conditions as L1 and L2. Reach contains some eroding banks with recruited wood spanning the channel. There is a bedrock channel at upstream end. Use grip hoist to maneuver existing downed wood into channel and to fell hillslope firs and place in channel. Good location for helicopter placement as well. At downstream end river-left, there appears to be a small push-up levee, but origin is unclear. Remove if possible or use jams to direct flow into levee to erode levee and activate the left bank low surface.	Machinery access likely not possible. Good location for helicopter placement of wood and/or using hand crews with grip hoists pulling down firs on hillslopes.

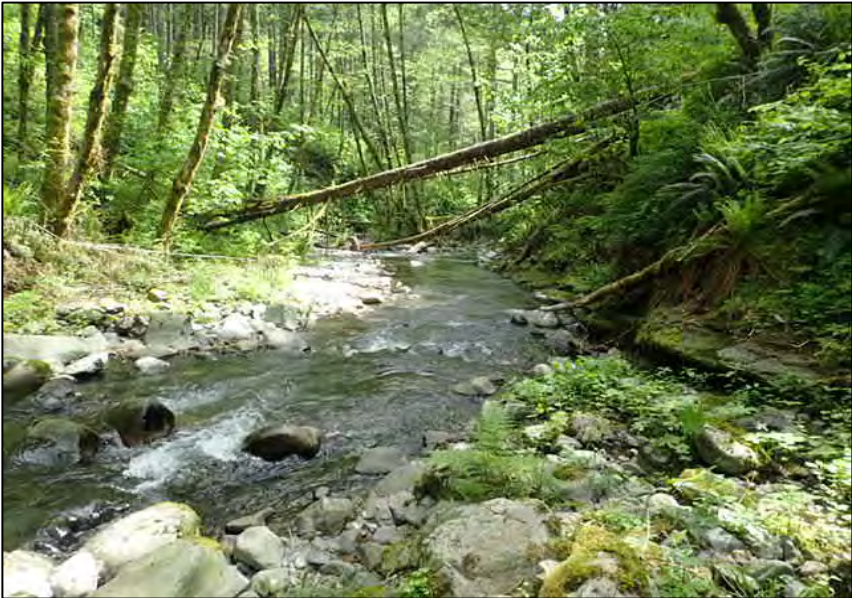
Reach	Project Name	Project Code	Project Description	Considerations	Photo
Little Wind 1	Powerline	L4	This is above a downstream more confined reach with landslides, more abundant large wood, and boulder-bedrock channel. Beginning here, and continuing upstream, is a lower gradient channel with occasional broad floodplains. But the channel has incised into this floodplain in many areas and there are many plane-bed sections and low large wood numbers. The riparian and floodplain is primarily young alders. Place large wood and log jams to activate and reconnect the floodplain, reconnect side-channels, create complexity, trap gravels, force pool-riffle channels, and maintain scour pools.	USFS (Scenic Area) lands. Can obtain machinery access via an old logging road.

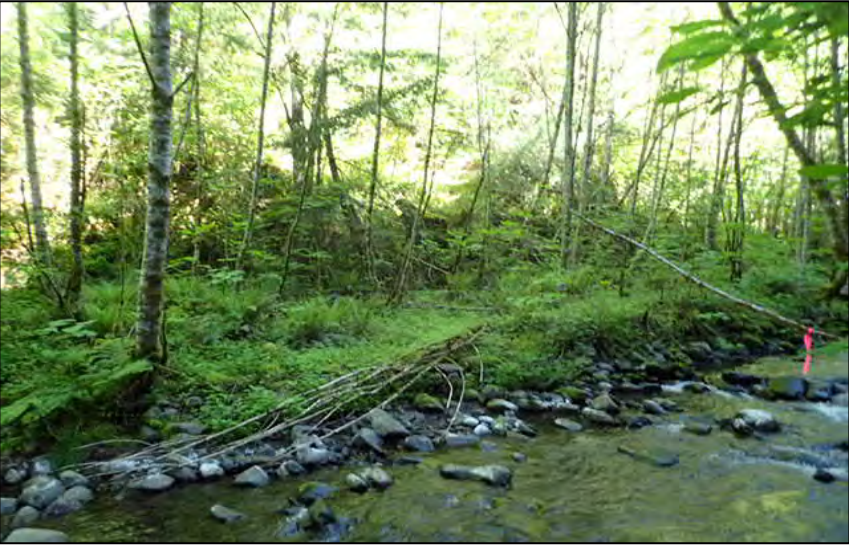
Lower Headwater Flats	L5	Similar conditions and opportunities as L4. Long relic side-channels that are relatively disconnected due to channel incision. Channel contains long plane-bed riffles. There are large stumps and logging debris (cables) on site. Place large wood and log jams to activate and reconnect the floodplain, reconnect side-channels, create complexity, trap gravels, force pool-riffle channels, and maintain scour pools. Plant cedar to jumpstart succession under alder canopy; focus on planting along wide benches along stream.	USFS (Scenic Area) lands. Can obtain machinery access via an old logging road.

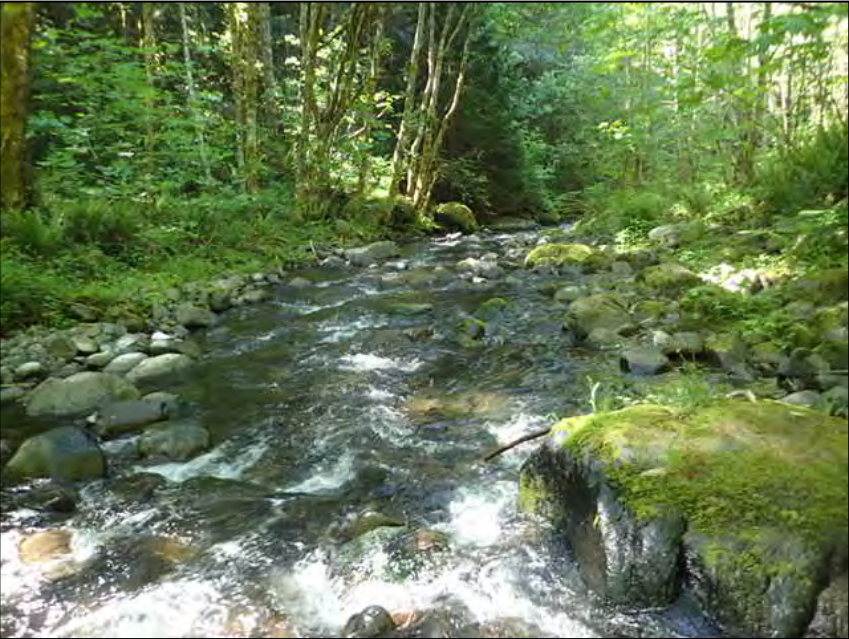
Reach	Project Name	Project Code	Project Description	Considerations	Photo
Little Wind 1	Middle Headwater Flats	L6	Similar conditions to L4 and L5. Wide floodplain benches but stream appears incised and somewhat disconnected. Add jams to activate floodplains and side-channels and to enhance channel complexity. Consider shifting main channel into more complex and sinuous alignment in floodplain. Depending on access conditions, either use helicopter, local felling of trees, or machinery.	USFS (Scenic Area) lands. Potential machinery access via old logging road, or from downstream access point. Otherwise, use hand crews with grip hoists or helicopter placements.

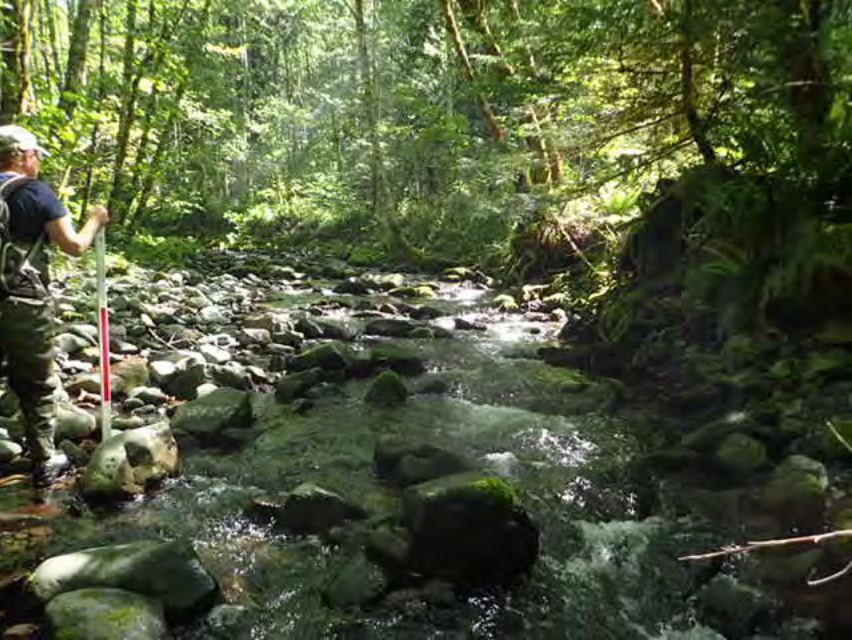
Upper Headwater Flats	L7	Similar conditions to L4, L5, and L6. Wide floodplain benches but stream appears incised and somewhat disconnected. Add jams to activate floodplains and side-channels and to enhance channel complexity. There are some areas already exhibiting complexity that would be improved by additional wood. Depending on access conditions, either use helicopter, local felling of trees, or machinery.	USFS (Scenic Area) lands. Potential machinery access via old logging road, or from downstream access point. Otherwise, use hand crews with grip hoists or helicopter placements.  Upstream of this site is more confined with more abundant large wood contributed from steep hillslopes.
