# Lower Cowlitz River and Floodplain Habitat Restoration Project Siting and Design

## **Final Revised Report**

December 2007

*Tetra Tech, Inc.  
Portland, Oregon*

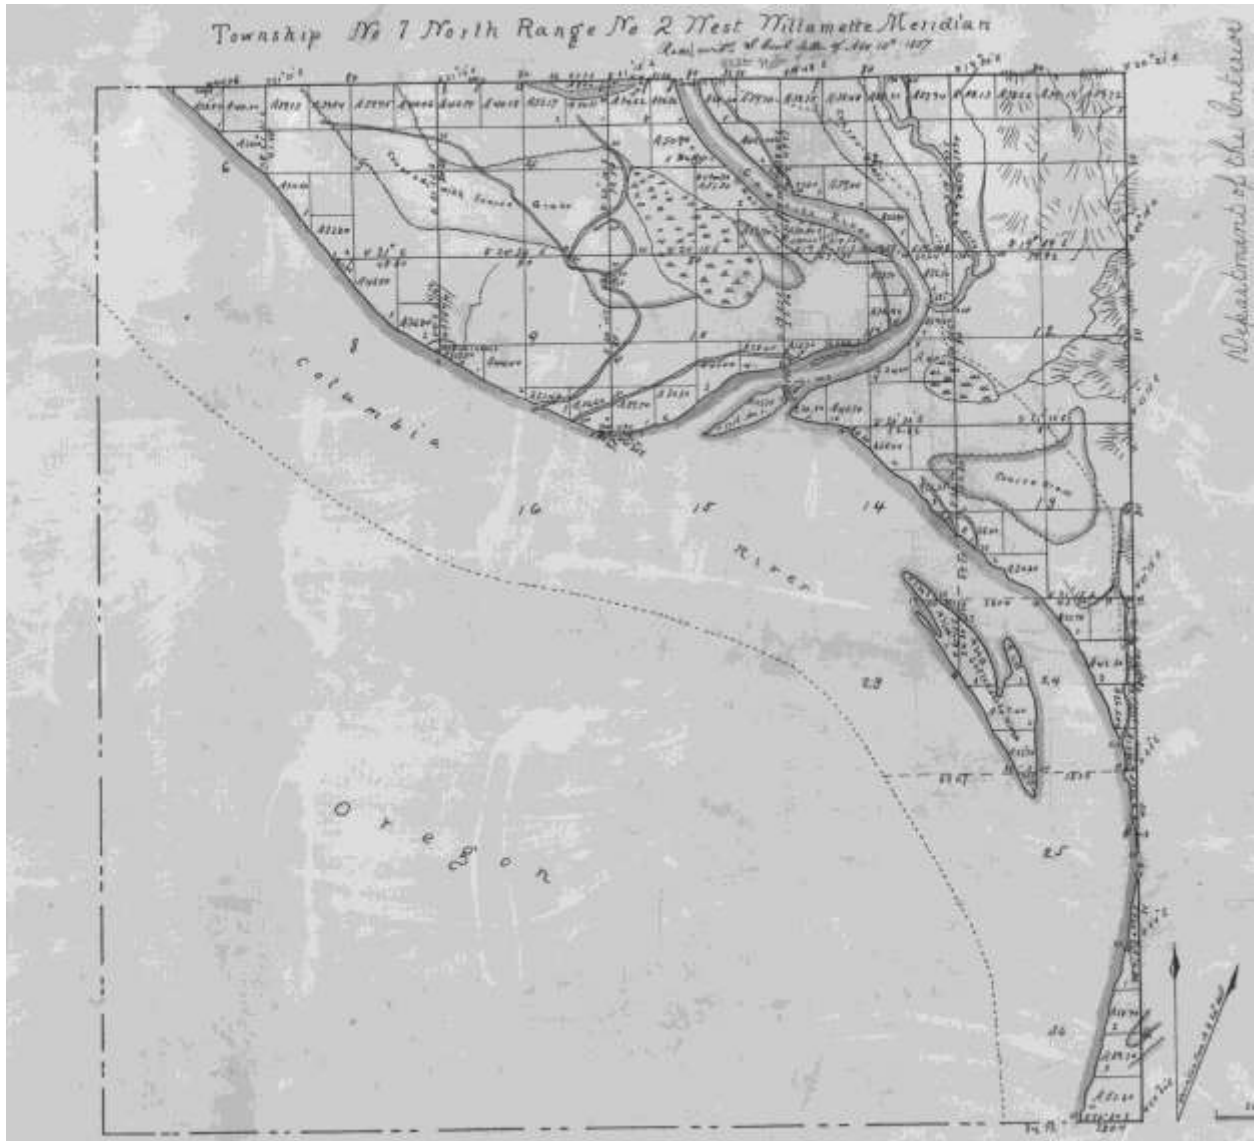
**Figure 15. Historical GLO Map of the Cowlitz/Columbia River Confluence (USBLM 1884)**

Comparisons between the historical GLO map and recent aerial photographs (**Figure 16**) do not show significant changes in the Lower Cowlitz main channel location and position. However, the establishment of industrial and commercial complexes and residential development in the floodplain has significantly modified floodplain features. Many of the historical backwater sloughs and tributaries have been channelized and rerouted to drain the area for development. In particular, as shown in **Figure 16** on the west side of the Cowlitz River, Lake Sacajawea and the Log Pond appear to be remnants of the distributary channels and wetland habitats shown in

**Figure 15.** Currently, the industrialized waterfront has limited fish habitat available and water quality issues upstream towards the sewage treatment plant in West Kelso (pH, temperature, fecal coliform, arsenic). To the east side of the Cowlitz, less commercial and industrial development has occurred with the primary human influences on the river being transportation infrastructure (such as the I-5 corridor) and spoils disposal from past dredging operations.

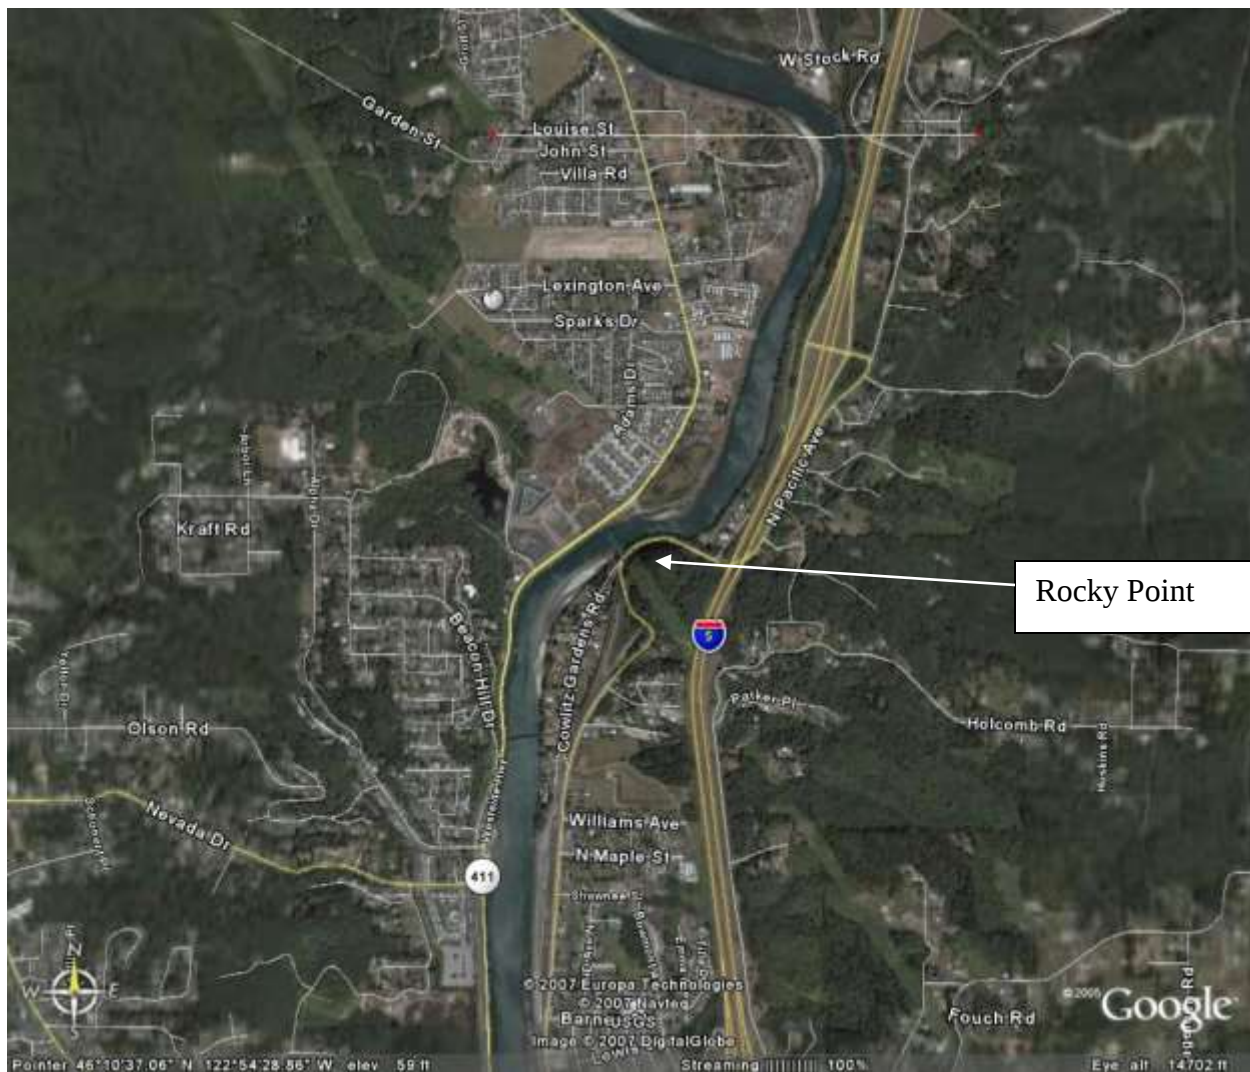
**Figure 19. Current Aerial of the Cowlitz River near Lexington (Google Earth 2007)**

The historical GLO maps indicate that the Cowlitz River occupied a somewhat different location in 1884, further to the west at River Mile 7.2 (**Figure 18**). The map shows the river much further to the west, opposite of Rocky Point. In its current configuration, the river abuts Rocky Point with the areas behind Westside Drive and levees occupied by residential areas of Lexington (**Figure 19**).

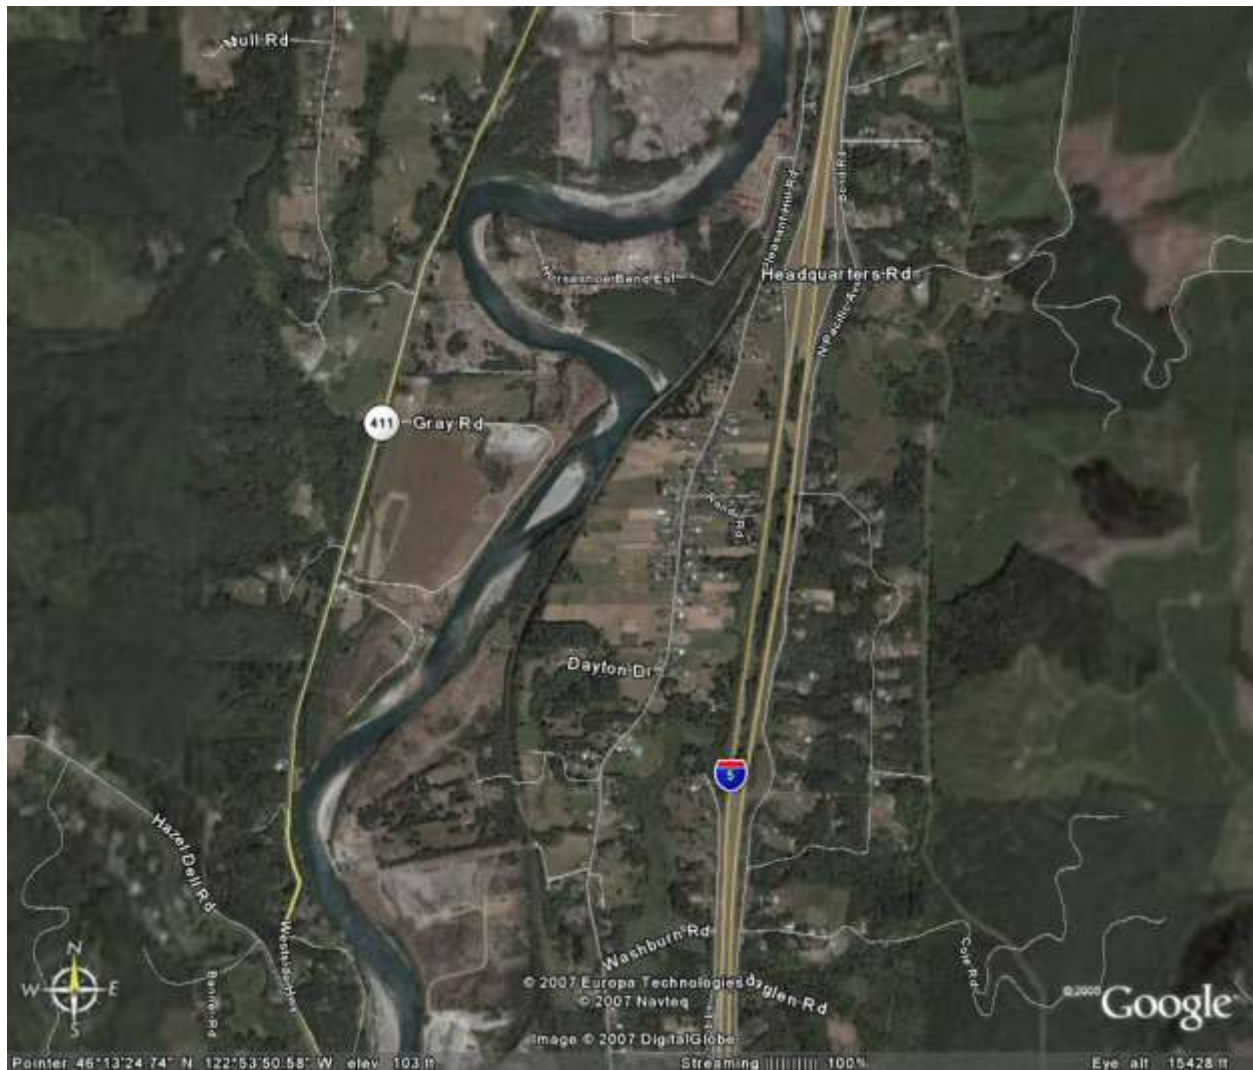
**Figure 22. Current Aerial of the Cowlitz River at Horseshoe Bend (Google Earth 2007)**

**Figure 23. Current Aerial of the Cowlitz River near Castle Rock (Google Earth 2007)**

**Figure 24. Current Aerial of the Cowlitz River Upstream of Castle Rock (Google Earth 2007)**

A comparison of the historic 1884 condition (**Figure 21**) to the current conditions of the river channel (**Figures 22-24**), shows the river follows a similar alignment from RM 10-17, up to Castle Rock. A large pond or wetland area is shown in Figure 21 to the east of the river that appears to be fed by the small tributaries from the east. This area is still mapped as floodplain on FEMA maps and is located along the I-5 corridor where two small tributaries enter the Cowlitz River. Upstream of Castle Rock, the historic alignment of the river was somewhat to the east of its current alignment. Anecdotal information from long-term residents indicates the Toutle River now enters the Cowlitz River upstream of where it historically did (D. Becker, pers. comm. 2006).

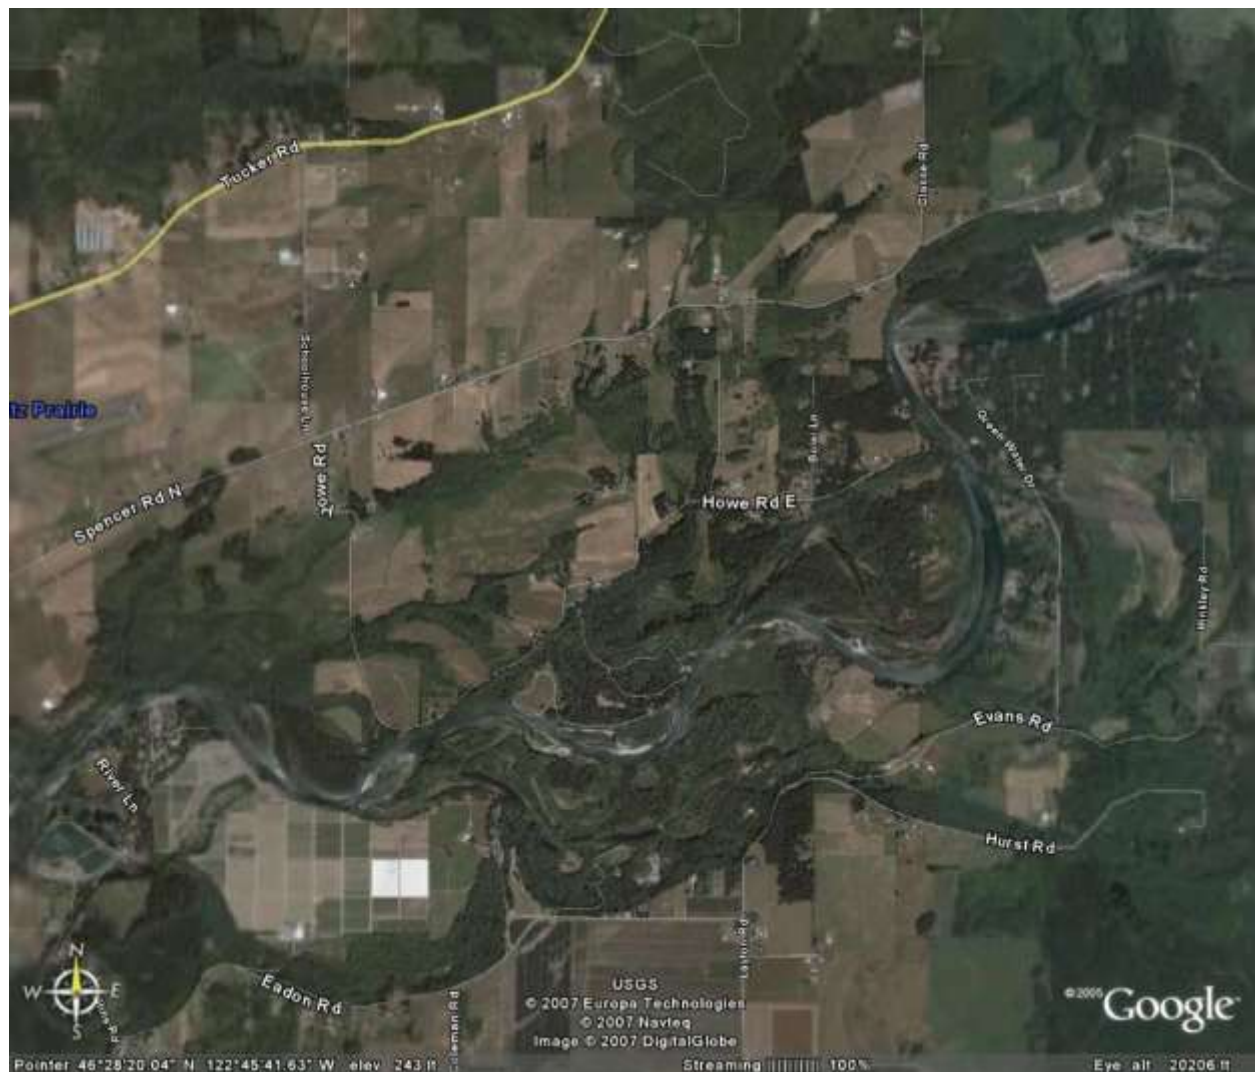
**Figure 38. Current Aerial of the Cowlitz River near Blue Creek (Google Earth 2007)**

**Figure 36** shows there is still meandering and extensive gravel bar movement downstream of Toledo and was also observed following high flows in the fall of 2006 and 2007. **Figure 37** shows the location of several gravel mined floodplains that could be restored and reconnected. **Figure 38** shows the large meander bends near RM 38-40 that are undeveloped and historically had multiple channels. Protection of this channel migration zone would protect a significant quantity of habitat.

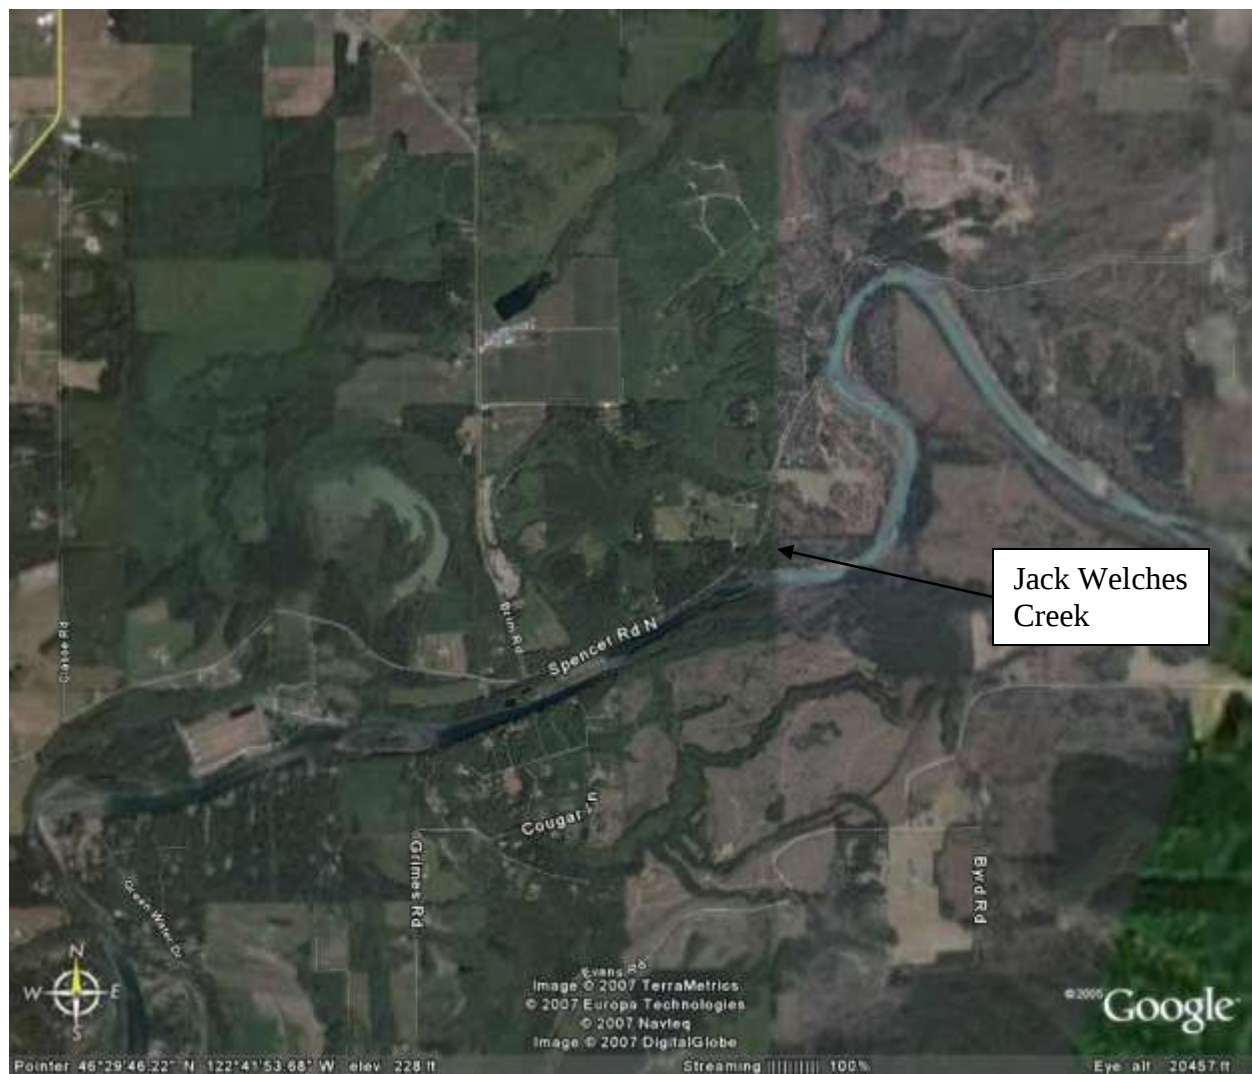
**Figure 41. Current Aerial of the Cowlitz River Upstream of Blue Creek (Google Earth 2007)**

Another opportunity within this reach is a potential channel migration zone easement and restoration in the area near Jack Welches Creek on the right side of the river near RM 44 (**Figure 41**). It appears this area may still be within the active floodplain and channel migration zone. However, it does not appear that the Blue Creek to Barrier Dam reach of the river is at risk for development and degradation in the immediate future. Therefore, large scale conservation purchases are not likely to be worth the cost. Focusing efforts on the mainstem and side channels is likely the best strategy for this section of river.
