# Woodward Creek Habitat Restoration Project Siting and Design Project

## **Final Report**

November 2007

*Tetra Tech, Inc.  
Portland, Oregon*

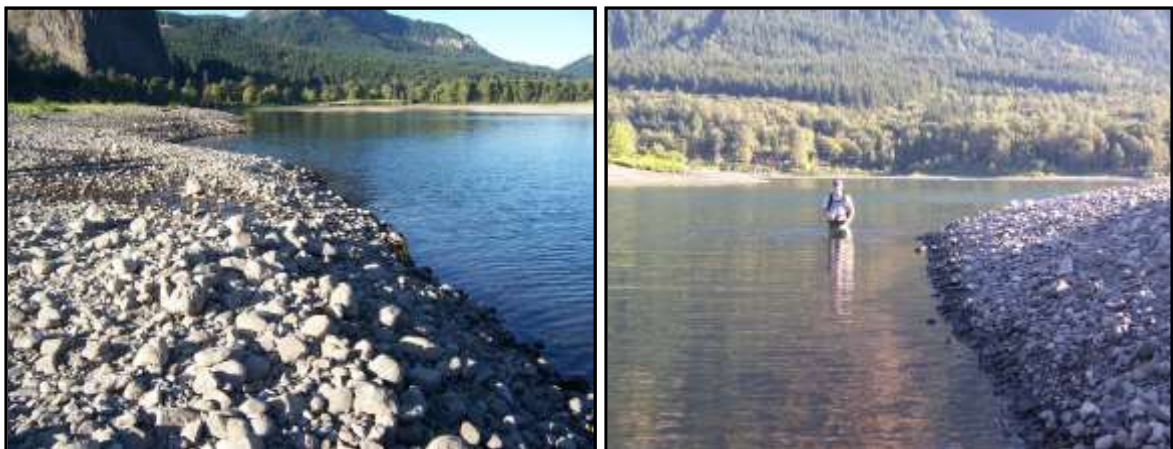
**Figure 3.** Mouth of Woodard Creek when Columbia River elevation at Bonneville = 7.0 (September 2006). *Note the 3 to 4 foot steep drop which Woodard Creek cannot scour due to backwater.*

- **Mouth at Columbia River:** Near the mouth of Woodward Creek the Columbia River water surface elevation fluctuates 14 feet on average, with the highest water levels occurring in June and the lowest in October. This creates a backwater in the lower 700 feet of Woodward Creek. High water for Woodward Creek occurs during November through February when the Columbia River is usually at a low to average water level; thus causing sediment to deposit near the mouth of the creek forming a delta. Fish passage becomes a problem at the mouth of Woodward Creek due to a steep drop over large cobble, when the Columbia River elevation at Bonneville Dam is below 10.0 feet. (USGS 2007)

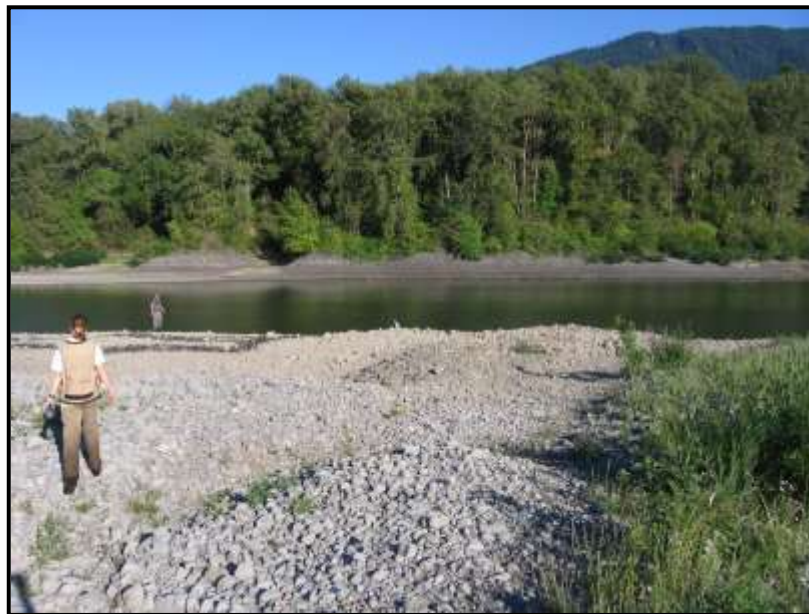
**Figure 7.** Mouth of Woodward Creek during Low Flows in Columbia River (September 2006).

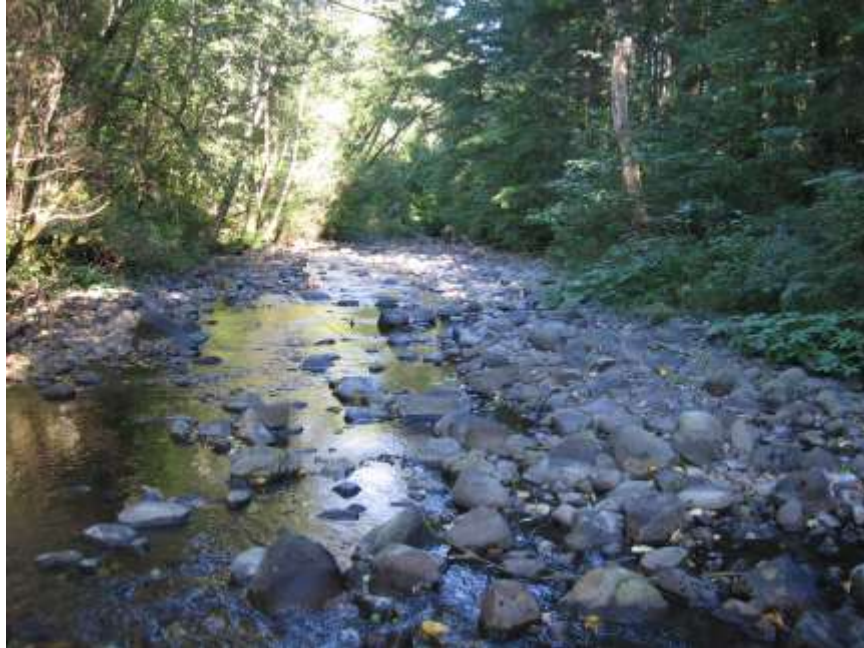
**Figure 8.** Reach 2, Typical Uniform Channel.

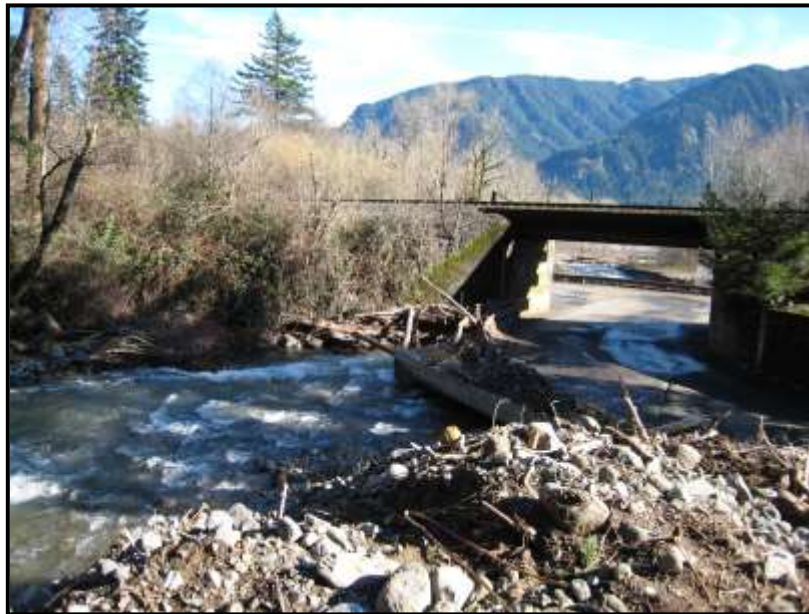
**Figure 9.** Railroad Culvert and Roadway after 2006 High Flows (January 2007).

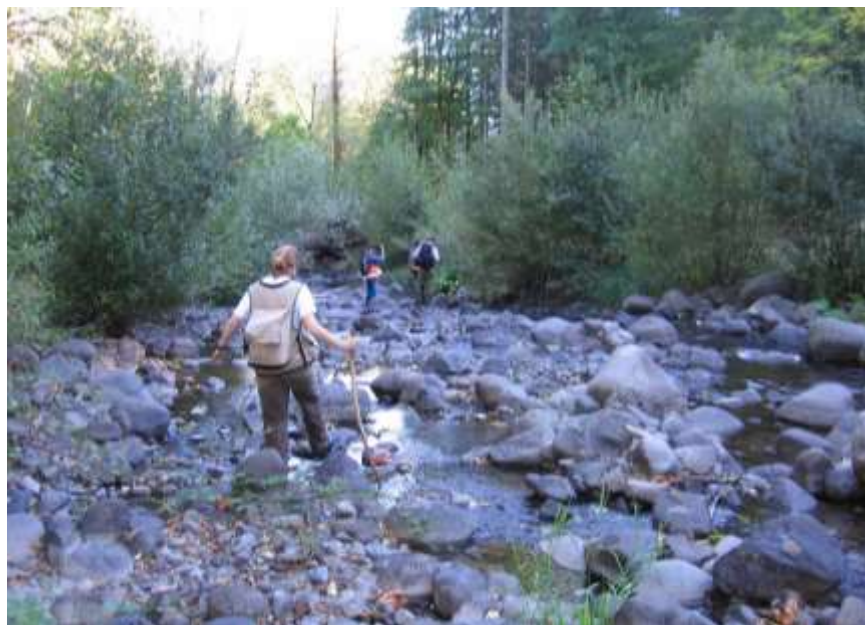
**Figure 10.** Reach 3; Typical Wider Floodplain Section before November 2006 Flood.

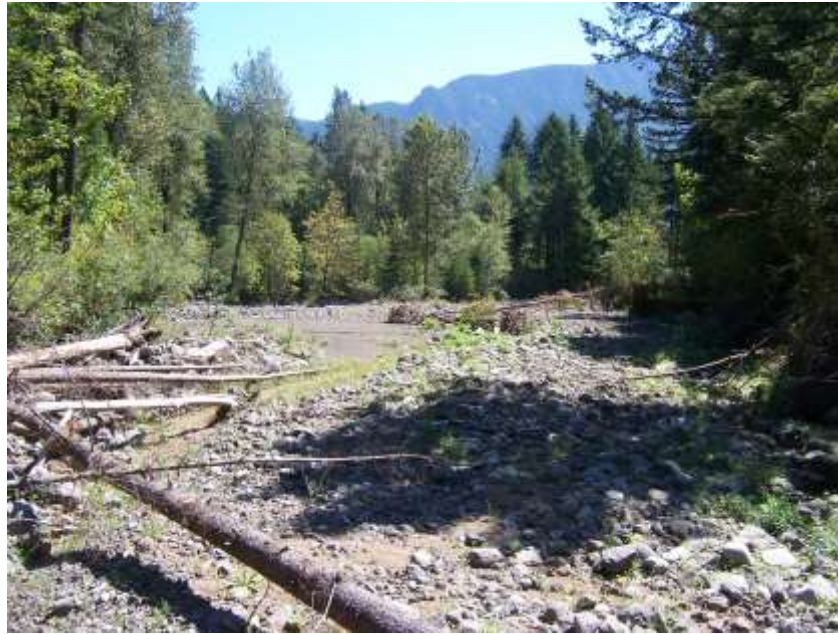
**Figure 11.** Reach 3, After November 2006 Flood.

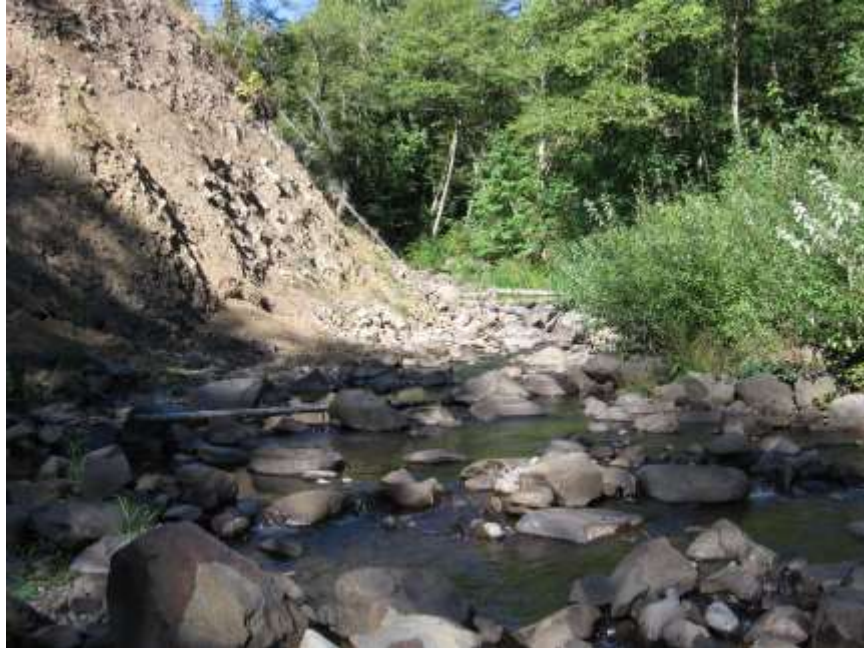
**Figure 12** Eroding Bank Near Downstream End of Reach 4

This reach extends from the confluence with East Fork Woodward Creek up to RM 2.0. This reach is within a narrow ravine and has two bedrock outcrop falls of 6 to 8 feet in height. The left bank is eroding at the powerline crossing and the right bank is eroding near the bedrock falls (**Figure 12**). These slides are contributing gravel, cobbles, and clay to the channel. Some of the eroding banks are dominated by red clays, while others are a compressed conglomerate of silts and cobbles. The channel substrate is dominated by cobbles and boulders and bedrock. The wetted width varies significantly in this reach from 10 to 20 feet depending on the presence of large boulders. The powerline is a dominant feature in this reach and has caused the removal of a significant amount of riparian vegetation, and invasion by non-native species such as Himalayan blackberry. Recent observations at the power line crossing indicate that coho and steelhead may spawn extensively in upper end of Reach 3 and also in Reach 4. Significant numbers of juvenile coho salmon were observed in August 2007 both upstream and downstream of the powerline crossing.

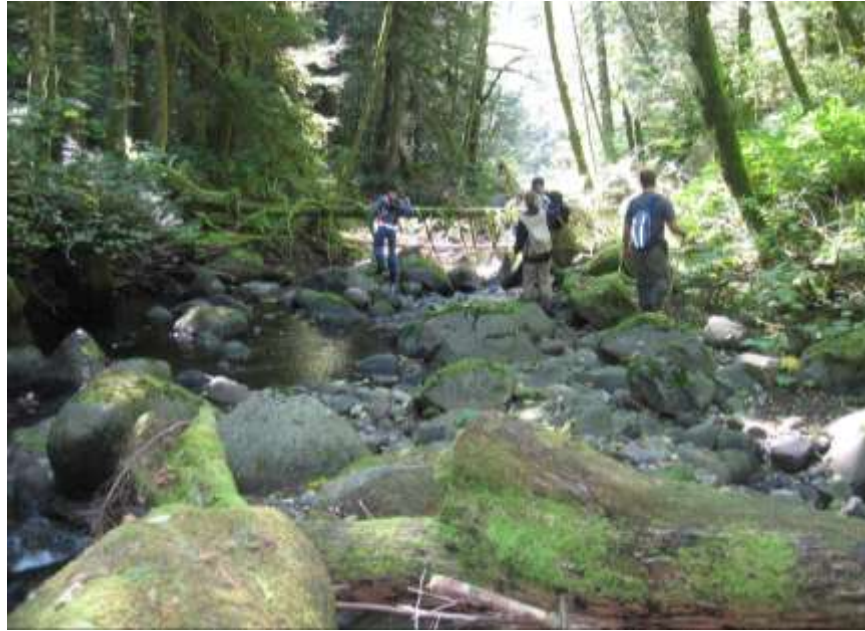
**Figure 13.** Reach 5; Typical Boulder Section.

This reach extends about ½ mile in length from about RM 2.0 to 2.5. The gradient increases in this reach (~11%) with several boulder drops of 6 to 8 feet in height. The boulders in this reach are large, with some up to 6 feet in diameter (**Figure 13**). There are small pocket floodplain areas in this reach, typically only on one side of the channel that may reach up to 100 feet in width for a short distance. The wetted width during low flow averaged about 13-15 feet and the bankfull width is about 40 feet. A slide is present in this reach contributing compacted clays and other fine materials to the channel. This slide has temporarily filled in the channel for up to 1000 feet downstream. The riparian and floodplain vegetation is primarily alder and cedar approximately 20-30 years old, although there are remnant large cedars up to 6 feet in diameter or greater and the riparian zone generally provides 100% canopy cover. There are scattered individual pieces of wood in this reach and a couple of channel spanning jams. The large boulders and wood trap some gravels and steelhead have been observed spawning in this reach by the LCFEG.

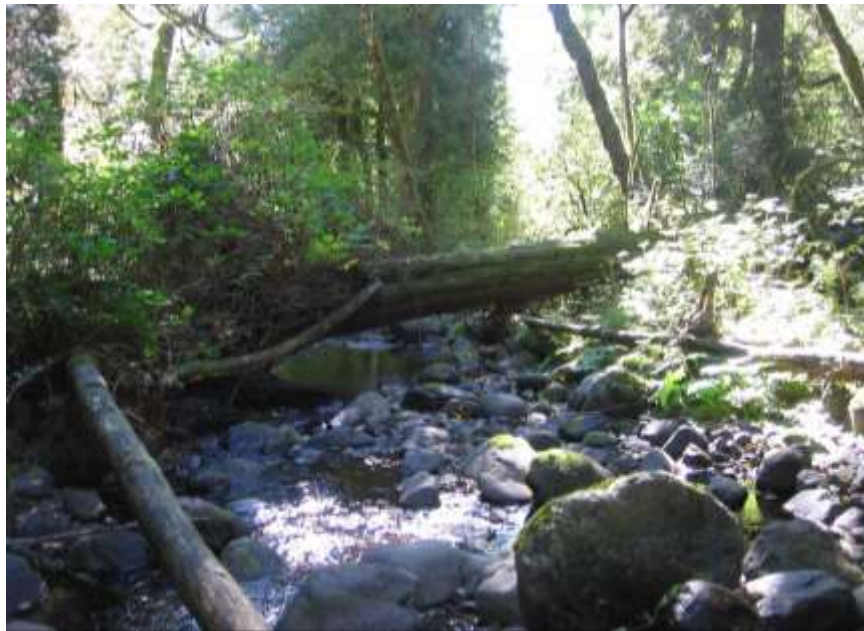
**Figure 14.** Reach 6, Showing Channel Spanning Logs.

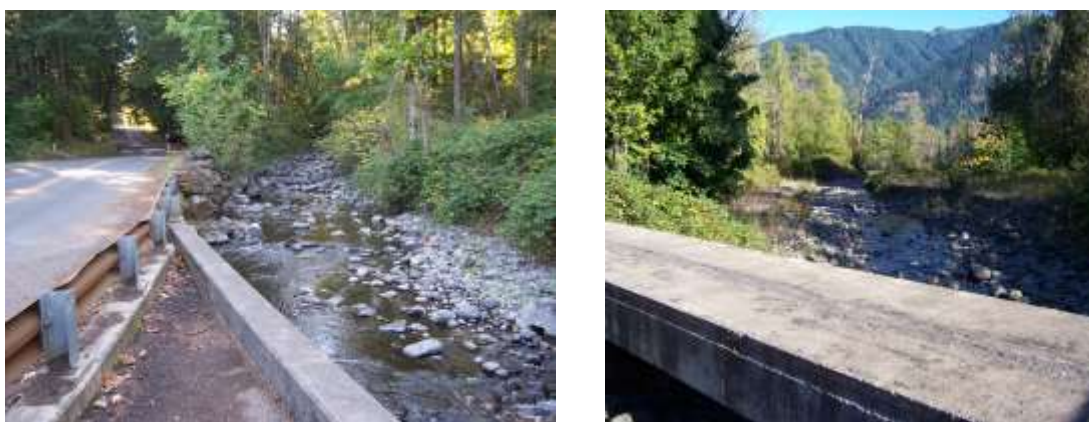
**Figure 15.** Channel in Vicinity of Moorage Road. *Left, looking upstream; right, looking downstream into Reach 1 (September 2006).*

Reach 2 can best be described as a transitional plane bed reach (Montgomery and Buffington 1998) with a generally featureless gravel/cobble bed (**Figure 15**). The upper section of Reach 2 is confined and the lower reach unconfined. This transition, the proximity of Moorage Road and the bridge downstream is the reason sediment builds up here during a channel threshold disturbing event. Herein is a key opportunity for habitat restoration via the installation of LWD and by reducing the channel confinement to transition the current reach from a plane bed to a pool/riffle type channel, thus providing improved fish habitat features.

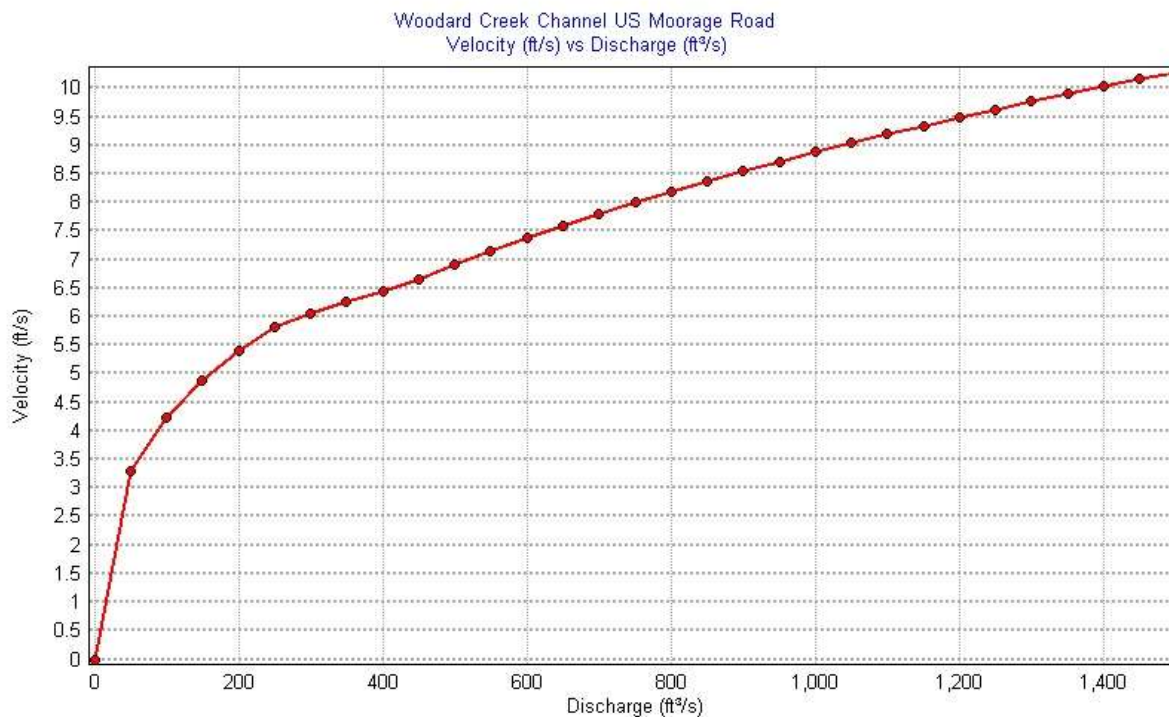
**Figure 16.** Woodward Creek Reach 2: Velocity and Discharge Rating.

One section upstream of the Moorage Road was analyzed using Flowmaster to estimate the relationships between discharge, velocity and depth. **Figure 16** shows a mean channel velocity of 9 feet per second (fps) at the 100 year flood of 1100 cfs. The reach slope is 0.023 ft/ft. **Figure 17** shows how depth varies with discharge. These velocity and depths are typical of Reaches 1 and 2, because channel width and slope are similar.

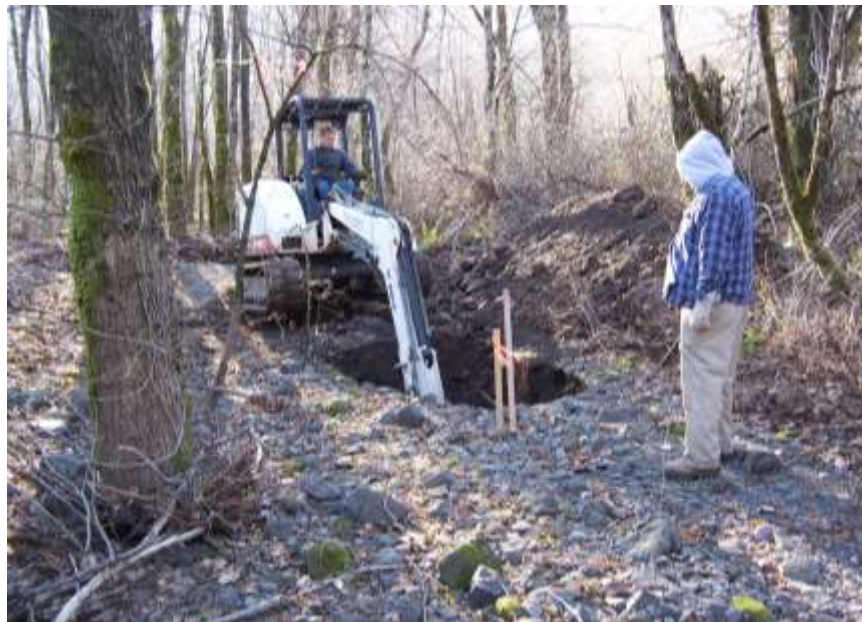
**Figure 20.** Typical Test Dig Layout in Proposed Side Channel Area.

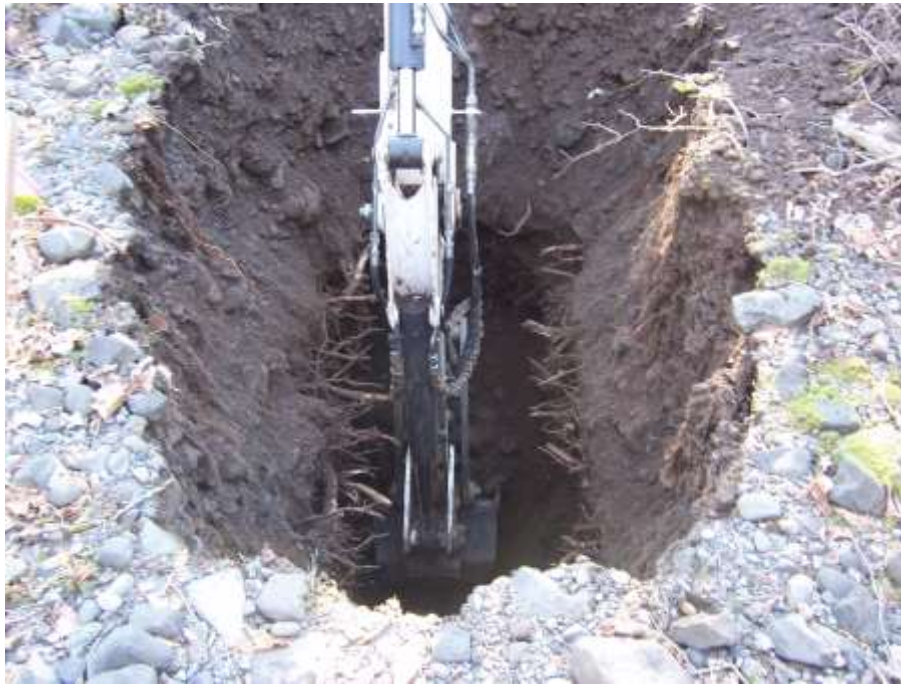
**Figure 21.** Excavation (typical) 8 to 10 Feet below Ground Surface.

The material can best be classified as well to poorly graded silty sand and gravel. Soils in the lower test pit were much smaller in grain size compared to the upper test areas which included more gravel. The most important finding from the test excavations was the absence of groundwater, and the presence of fine grained materials which could support a surface fed side channel restoration project. Grain size distribution for the excavated samples were much smaller than as determined from the pebble counts in the adjacent channel (1/2 to 1 inch compared to 5 inches) for the  $d_{84}$  size. This clearly shows the shallow overall depth of the alluvial flood plain material.
